# Article Time-Lapse Camera Monitoring and Study of Recurrent Breaching Flow Slides in Cap Ferret, France

Yves Nédélec \*<sup>D</sup>, Philippe Fouine, Cyrille Gayer and Florent Collin

Abstract: In this paper, we present a low-cost method designed to monitor recurrent breaching flow slides that impact the security of a beach. This beach, located in France at the inlet of Arcachon Bay, connects a sand spit to a tidal channel while ending at the toe of a coastal defense. Monitoring is based on capturing images and intends to add continuous information to intermittent direct observations so that triggering and influencing factors can be assessed more precisely. The method is based on time-lapse picture collection and processing. The field of view shows successive emerged manifestations of flow slide phenomena, as well as some possibly related environmental elements. On-site application for 576 days provides important indications and details on flow slide event progress and beach recovery. A simple but quantitative analysis of the influence of sand spit topographic changes is proposed as a preliminary approach of the method's suitability for studies of environmental processes in conj

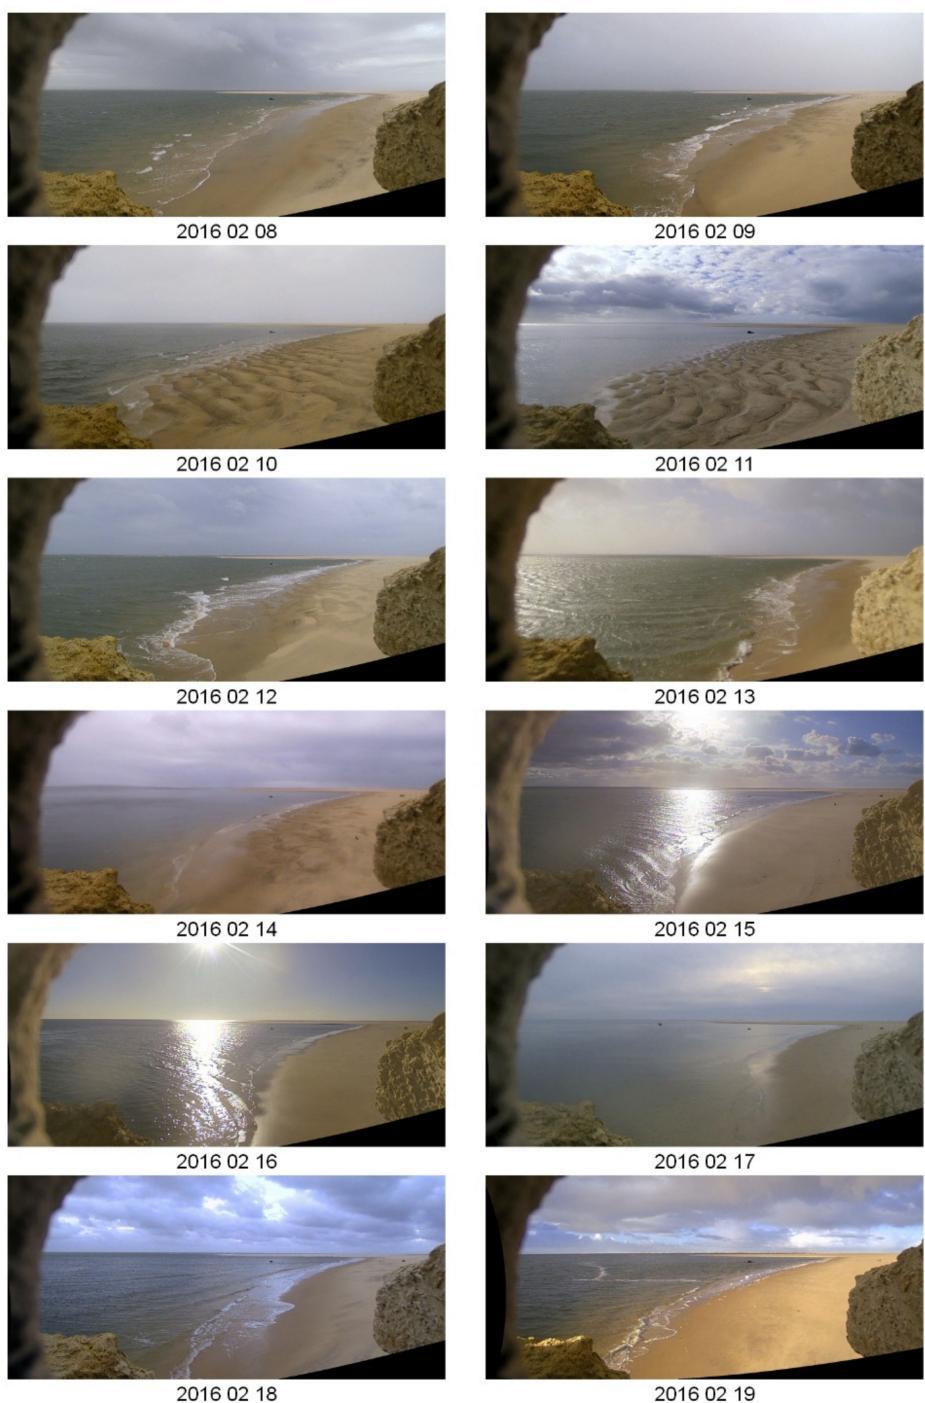
2016 02 19

Figure 19. Sequence of daily pictures during low flow slide activity.

An examination of daily images revealed that the end of the visible sand spit, moving southward and then regressing northward, might be related to changes in the flow slide regime. Figure 16 shows a dramatic cease in flow slide activity between November 2015 and May 2016. During this period, the sand spit was massive, whereas the beach was in a very flat and rippled shape, as shown in Figure 19. The southward extension of spit was particularly visible on 19 February 2016.

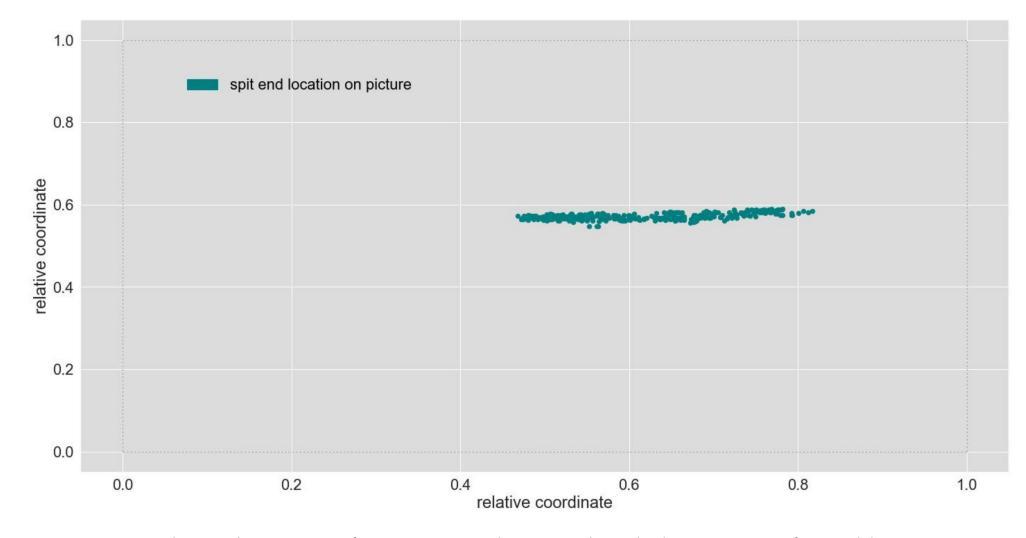
Figure 20. Relative locations of western sand spit end in daily pictures after calibration.

Locations of the end of the western sand spit in daily pictures (see Figures 5 and 8) were recorded in order to study its influence. For example, in Figure 8, the relative coordinates of the spit end are (0.47, 0.59). All daily relative coordinates are plotted on the graph in Figure 20. Despite the loss of accuracy due to distance- and calibration-related uncertainties, changes in the x value were considered as good indicators of a southward extension of the spit. This was simultaneously observed through topographic surveys by Nahon [17].

In the subsequent Discussion section, we develop an analysis, using the monitored data, of the relationship between the interruption of flow slide mechanisms, as seen in Figure 16, and movements of the sand spit, as seen in Figure 20.

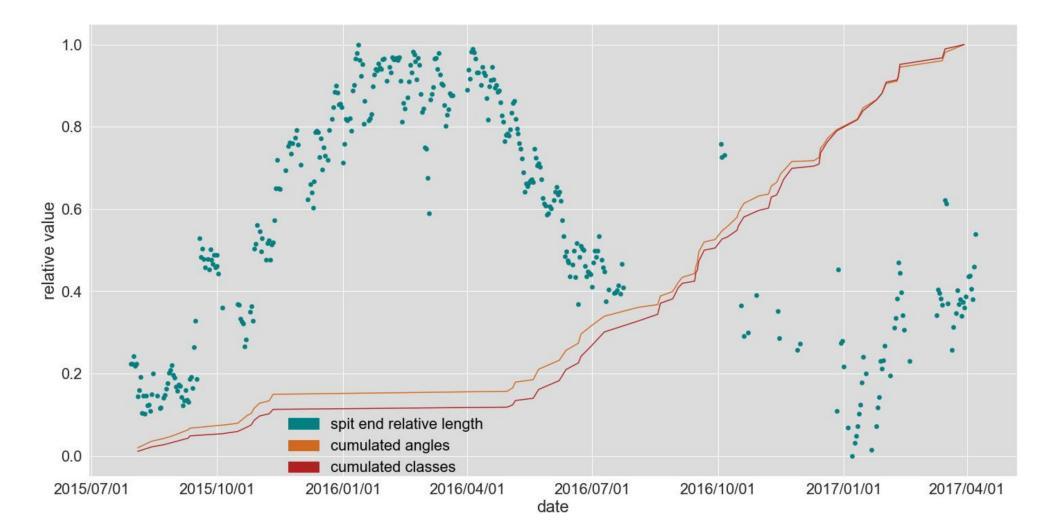
**Figure 21.** Timelines of cumulative sum of flow slide event angles and classes together with relative spit end lengths along the x coordinate.

Highlighting the relationship between sand spit changes in shape and flow slide activity was performed following a method developed for artificial drainage analysis: drainage discharge, characterized by a peak regime, is summed into a cumulative dataset and plotted as a function of rainfall or accumulated rainfall. This approach is of much help in studies considering environmental impacts on groundwater drainage [18,19]. Flow slide event angles were summed on the same principle and presented as a function of time, together with relative spit length along the x coordinate proportionally fitted between 0 and 1 (i.e.,  $(x - x_{min})/(x_{max} - x_{min})$ ). The sum of the visual classes was also plotted on a graph. This result is shown in Figure 21: blue dots indicate the evolution of spit length. Cumulative event intensity is drawn as two normalized curves of values, one for each classification method. Values range between 0 and 1. By doing so, both interpretations of curves appear to be convergent, despite differences between the classifications of larger events. The halt in flow slide dynamics can be precisely dated with this approach.

The slope of the curve indicates a relatively regular time distribution of flow slide intensity. A relationship between this slope and average sand flux through longshore drift may be assumed, if the volume of moved sand during each event can be associated unambiguously with each angle or class. This may be a goal for a future study including precise topographical surveys (see Section 5.2).

The graph in Figure 21 shows the concomitance between the ceased flow slide activity and end of the sand spit extending southwards. It can be seen qualitatively that after this maximum extension, sand accumulated at the spit moved towards the groyne, and refueled the flow slide regime. This regime appeared to be fairly constant during the experimental period.
