Supplementary Materials

S-type Dissolved Oxygen Distribution Along Water Depth in a Canyon-shaped and Algae Blooming Water Source Reservoir: Reasons and Control

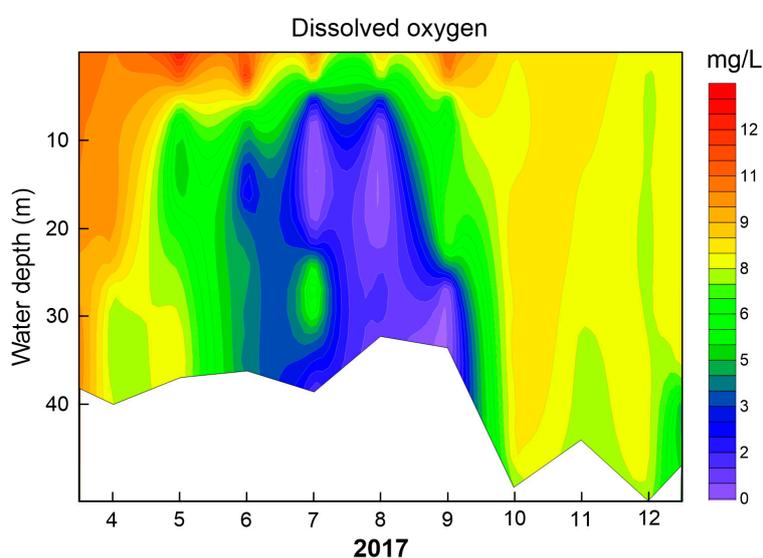
Figure S1. Seasonal DO depth profile of S2 site in Lijiahe Reservoir from April to December in 2017.

Figure S1. Seasonal DO depth profile of S2 site in Lijiahe Reservoir from April to December in 2017

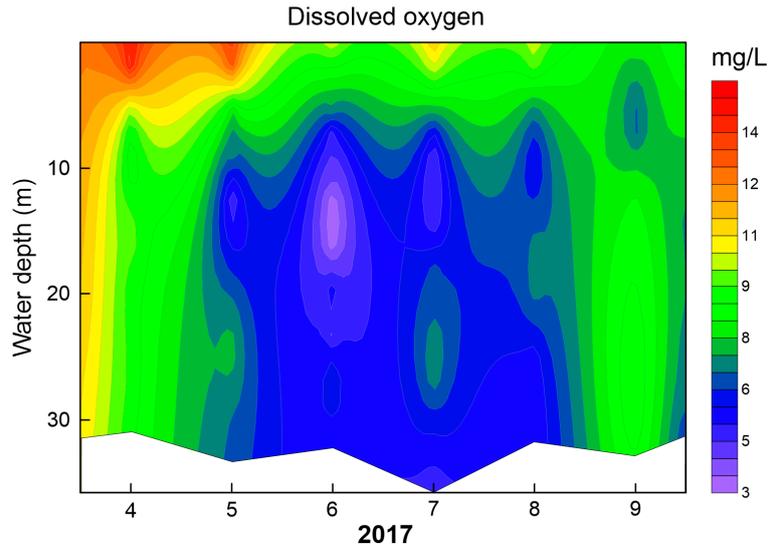
Figure S2. Seasonal DO depth profile of S3 site in Lijiahe Reservoir from April to September in 2017.

Figure S2. Seasonal DO depth profile of S3 site in Lijiahe Reservoir from April to September in 2017

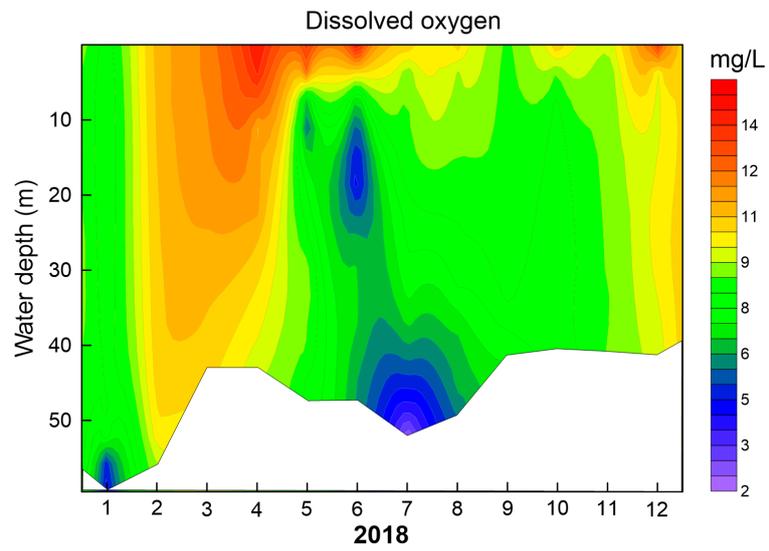
Figure S3. Seasonal DO depth profile of S2 site in Lijiahe Reservoir in 2018.

Figure S3. Seasonal DO depth profile of S2 site in Lijiahe Reservoir in 2018

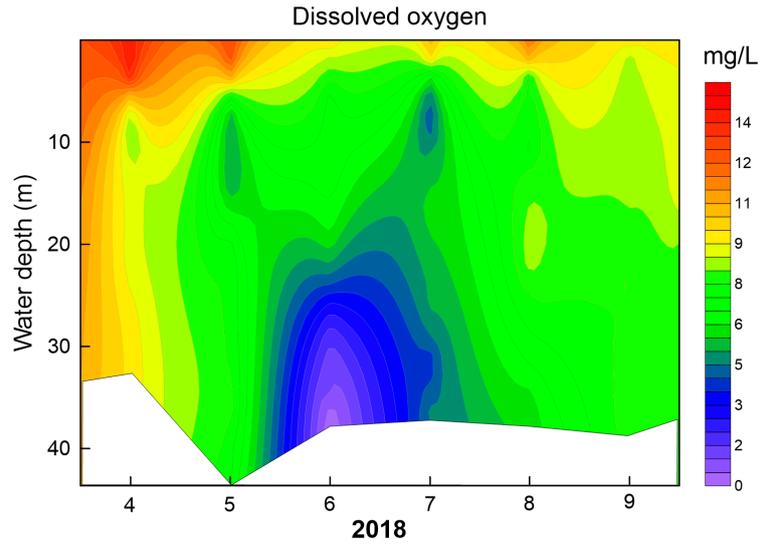
Figure S4. Seasonal DO depth profile of S3 site in Lijiahe Reservoir from April to September in 2018.

Figure S4. Seasonal DO depth profile of S3 site in Lijiahe Reservoir from April to September in 2018
