Article

# Analysis of Mechanical Behavior through Digital Image Correlation and Reliability of *Pinus halepensis* Mill.

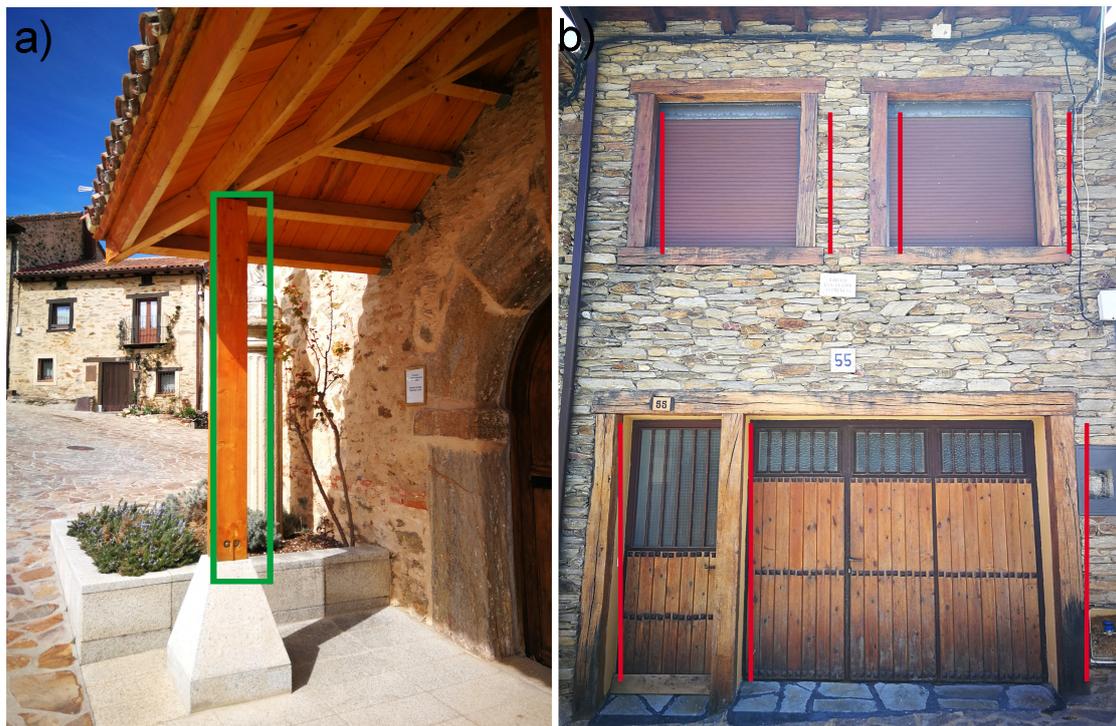
**Figure 1.** (a) Porch column of a church (Madrid) (green rectangle) and (b) pillar supports of a façade of a rural house (Madrid) (red lines).

It is necessary to highlight the differentiating characteristics of wood with respect to other structural materials [7], which demonstrates the existence of a multitude of wood species with varied intrinsic properties [8]. Thus, wood is a material with wide versatility and various possibilities for the same use. One of the most common structural applications of wood is that of a simple compression stress support element, functioning as a pillar in different types of structures (Figure 1).

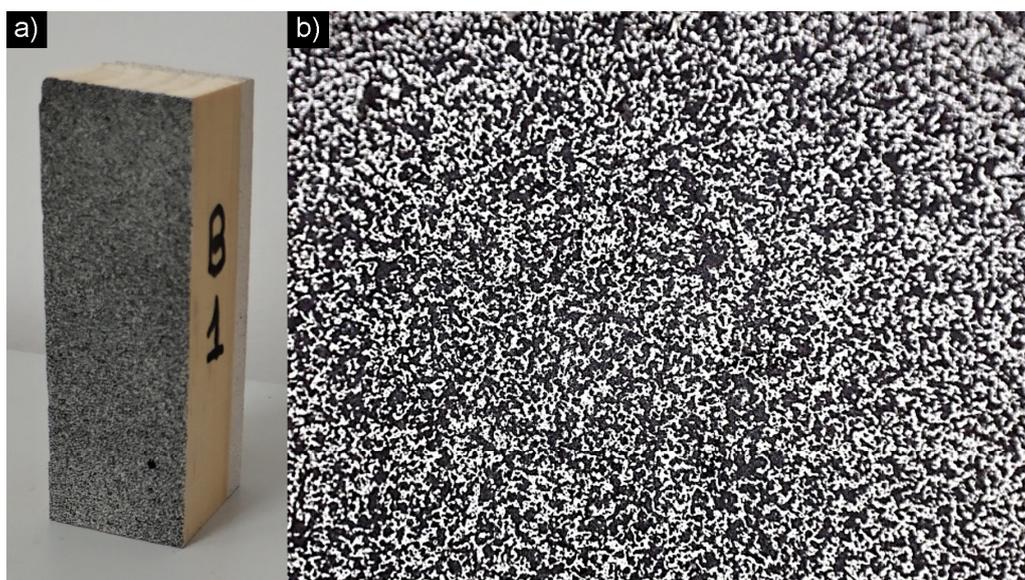
**Figure 2.** (a) Application of black speckled on a white base and (b) example of speckled pattern.

The specimens were pre-treated to allow deformation analysis using the DIC software. First, a matt white spray paint base was applied (to avoid glare and reflections, which reduce the quality of the images), and then a second layer of matt black spray paint was applied. The speckled distribution must not be uniform; thus, speckling is generated based on black points in contrast to the white background, allowing different shades of gray to be recognized on the study surface for the subsequent image analysis (IA). Figure 2 shows the pattern arranged on the samples to be tested.

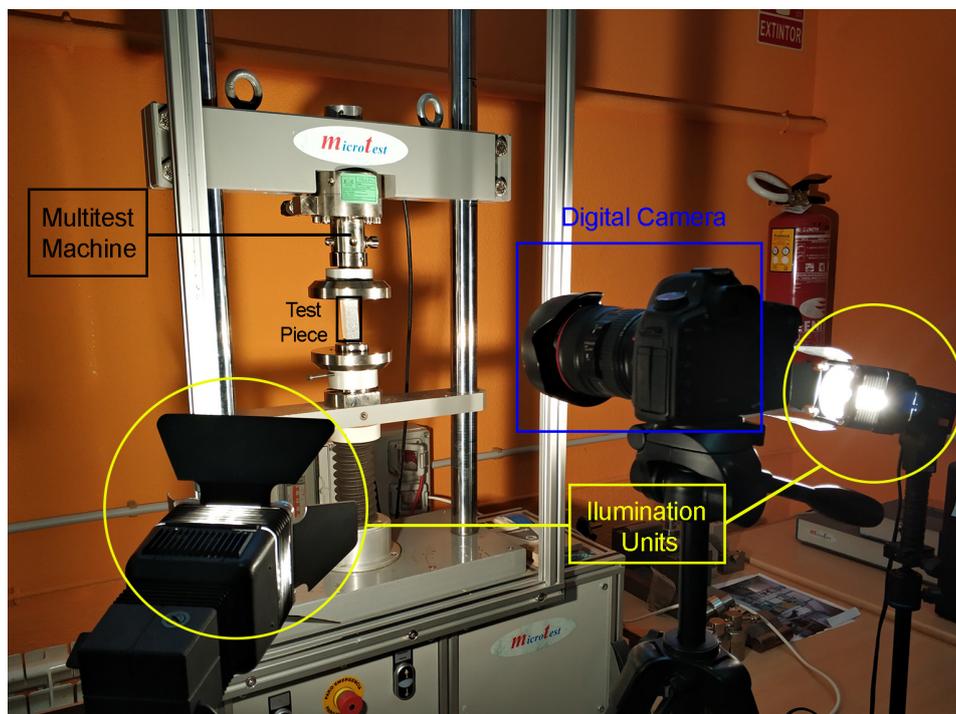
Figure 3. Complete test equipment.

To carry out the compression test, an electromechanical Microtest EM1/50/FR multi-test machine (Madrid, Spain) with a capacity of 50 kN and load resolution of 0.001 kN (Figure 3) was used.

Additionally, two lighting units were used during the tests to guarantee the quality of the light. These units were placed on both sides of the camera to avoid the appearance of shadows or glare that could later degrade the quality of the images, and consequently lead to distorted or erroneous deformation values. The arrangement of the test equipment is shown in Figure 3.

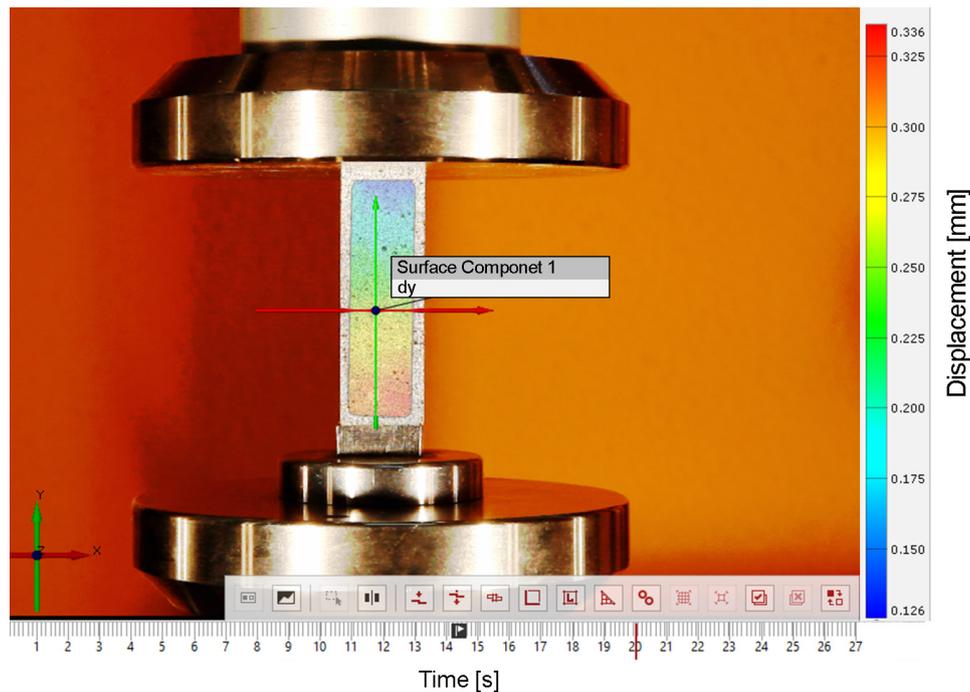
Figure 4. Study surface and color map of displacements.

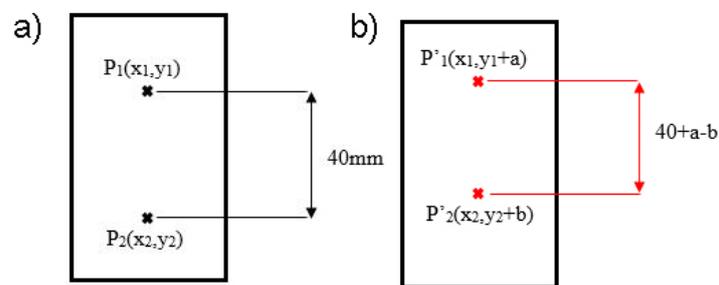
Figure 5. (a) Definition of points for the calculation of the strain and (b) displacement of the deformed points.

First, two points were defined in the initial reference image of the test whose coordinates were  $P_1 (x_1, y_1)$  and  $P_2 (x_2, y_2)$  (Figure 5a), and their initial separation was 40 mm.

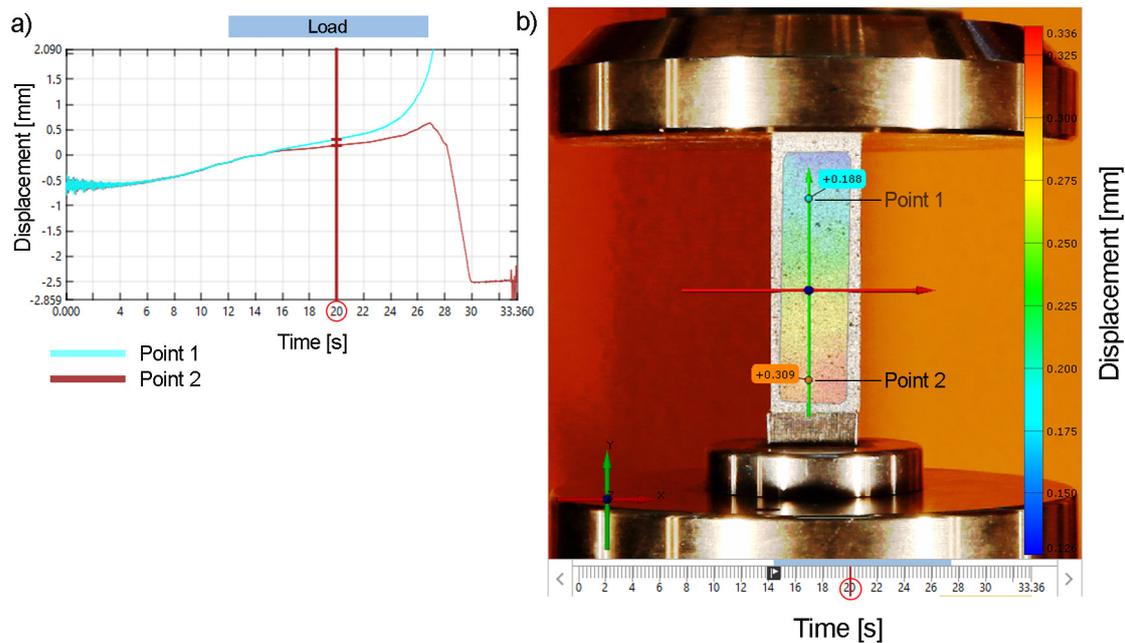
**Figure 6.** (a) Displacement/time diagram of points 1 and 2 and (b) displacement color map of test piece A1.

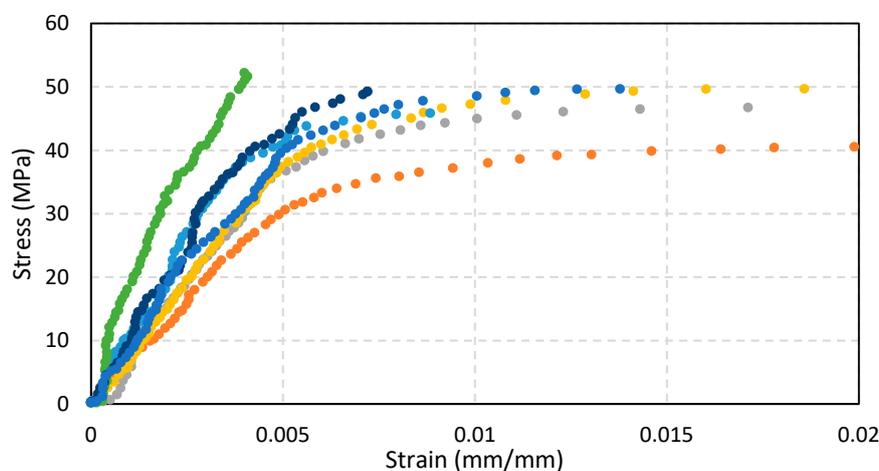
**Figure 7.** Comparison of the stress/strain curves of the Series A tests.

The behavior of wood usually passes through three different phases [51]: (a) the elastic zone; (b) the so-called elasto-plastic zone; and (c) the plastic or creep zone. Figure 7 shows stress/strain curves corresponding to the samples of Series A.

corresponding to 80% of the elastic limit. This can be seen in Figure 7, which shows that some samples do not follow the general trend.

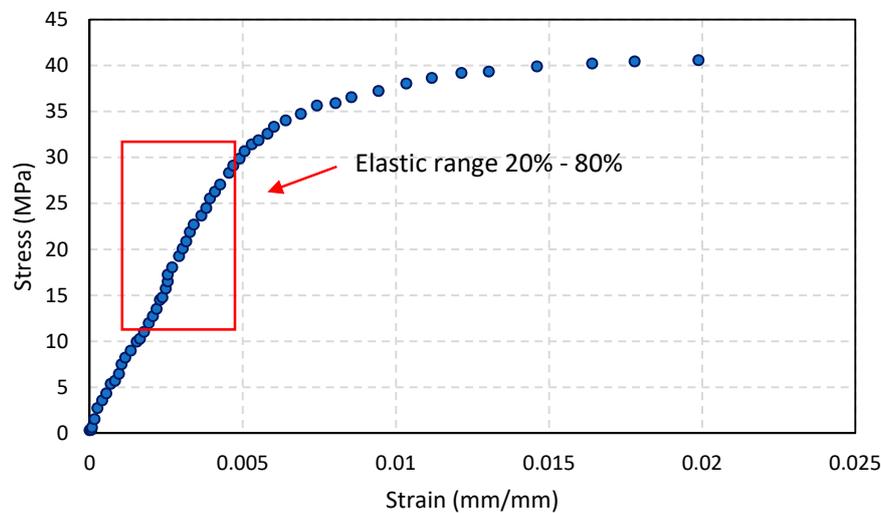
**Figure 8.** Area in which the modulus of elasticity in compression parallel to the grain ( $MOE_c$ ) is determined for specimen A1.

Figures 8 and 9 show the process for obtaining the  $MOE_c$  in the plotting of the curve for sample A1.

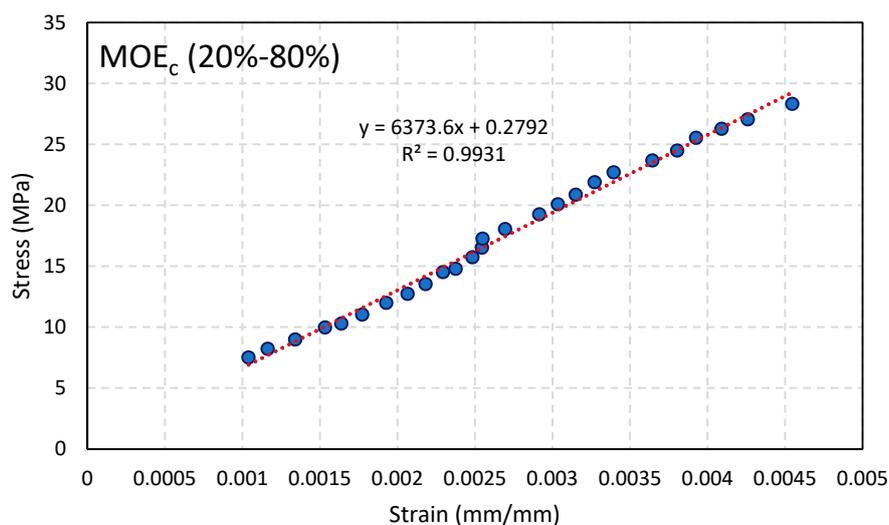
**Figure 9.** Determination of  $MOE_c$  in the 20%–80% interval (specimen A1).

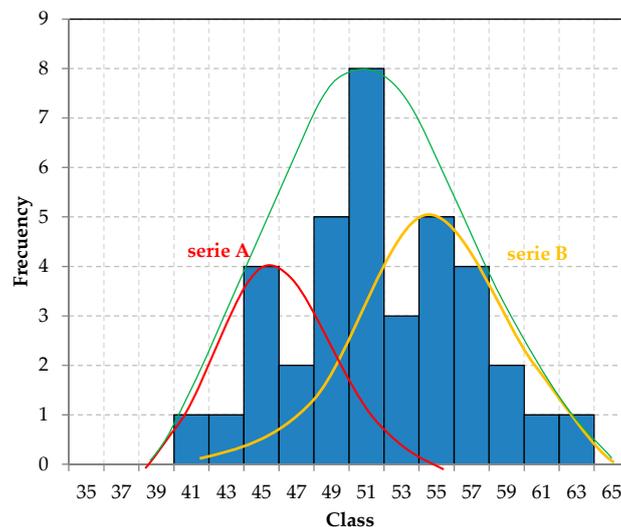
Figure 10. Histogram for  $MOR_c$  values of the total samples.

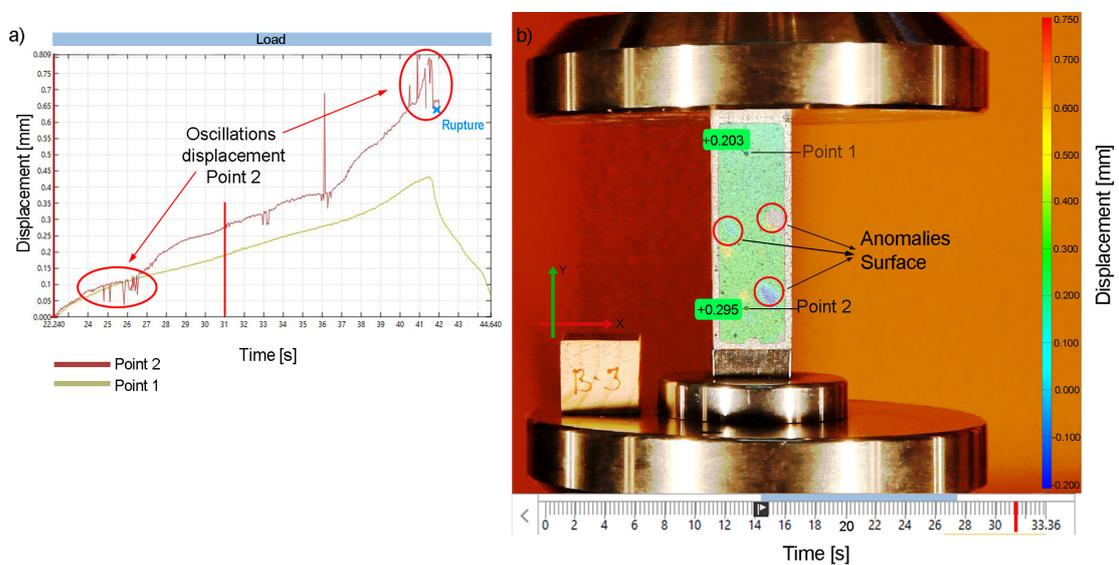
**Figure 11.** (a) Displacement diagram with oscillations of Point 2 ( $P_2$ ) and (b) anomalies of the displacements on the surface of specimen B3.

Figures 11 and 12 show the tests of two of the failed specimens, in which, due to the dotted texture, the anomalous areas that led to premature failure are clearly detected, even before their breakage. Thus, DIC is shown to be a sensitive and low-cost technique, compared to others, which directly and visually allows detection of faults and anomalous areas in the tested specimens.

An example is found in the case of test piece B3. In Figure 11a, point P<sub>2</sub> shows oscillations in its displacement throughout the loading process. In the diagram, the red line (corresponding to the evolution of the displacements of the lower point P<sub>2</sub>) undergoes large oscillations in certain sections, such as the intervals from 24 to 27 s and from 40 to 42 s. If the displacement map of the test piece is analyzed (Figure 11b), it is observed that the surface has certain areas in which the displacements are lower. This indicates the existence of defects or anomalies in the lower part of the specimen (coinciding with the final breakage of the specimen that occurs in the lower zone).

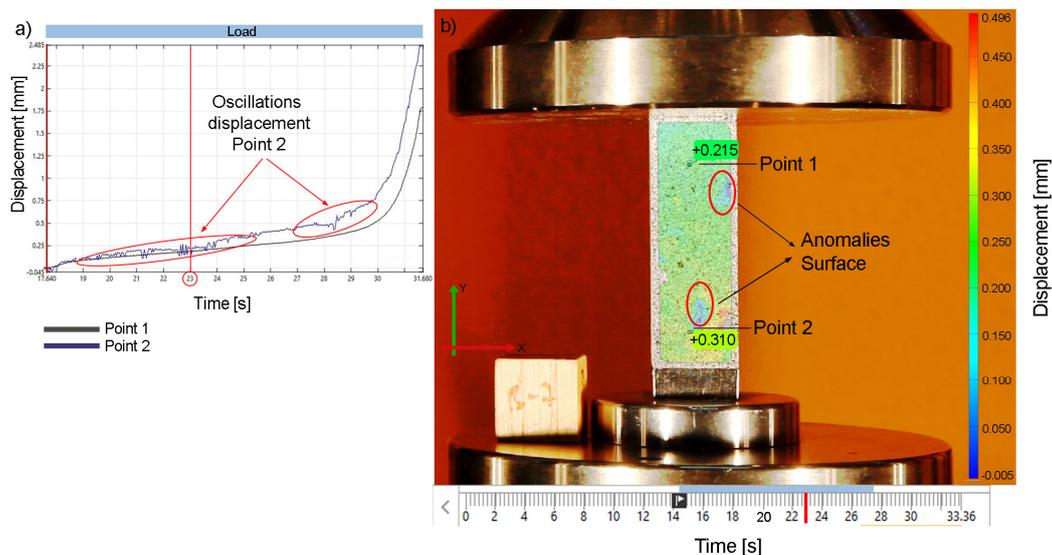
**Figure 12.** (a) Displacement diagram with oscillations of Point 2 ( $P_2$ ) and (b) anomalies of the displacements on the surface of specimen B7.

Another case is the specimen B7. In the diagram of Figure 12a, the blue line (corresponding to the evolution of the displacements of the lower point P<sub>2</sub>) undergoes large oscillations, mainly from the beginning to 26 s and in the interval from 28 to 29 s. However, the black line (corresponding to the evolution of the displacements of the upper point P<sub>1</sub>) appears to be regular. If the displacement map of specimen B7 is analyzed (Figure 12b), the surface presents certain areas in which the displacements are lower, as in the previous case. This indicates the existence of defects or anomalies in the lower part of the specimen.

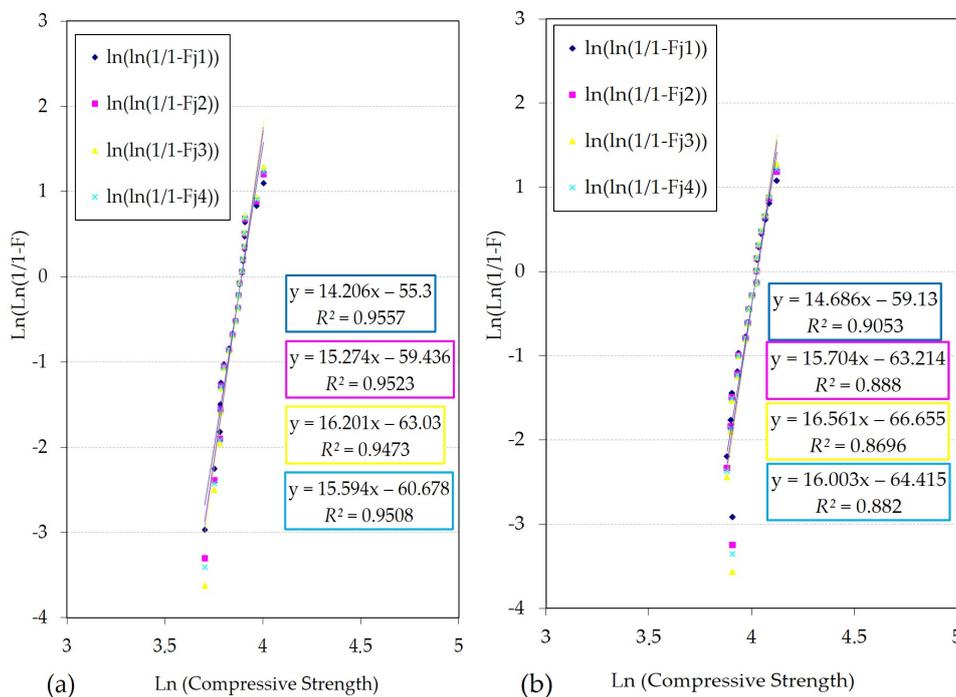
Figure 13. Weibull graphs for the series: (a) A series and (b) B series.

Wood is a widely used material that can experience random breaks and failures. Due to its natural variability, it is feasible to apply the Weibull distribution to determine its reliability and therefore its behavior in service. The Weibull graphs are plotted from the compression tests carried out on the wood specimens of both series (A and B). Because there were sufficient tests to carry out an acceptable reliability study on each series (A and B), their Weibull modules were determined as a measure of reliability in each tree (Figure 13).

As can be seen, the Weibull modulus is similar for both series with very close values for the best estimator Fj3 (Equation (10)), although the quadratic  $R^2$  fits are less than or equal to 0.90 for Series B, whereas for Series A they are greater than 0.95. Series B shows a Weibull modulus for the third estimator that is somewhat higher (16.561) but with a poor fit. A Weibull modulus of 16 (Fj3) for each tree (or series) can be considered acceptable and, within the same tree, the reliability is good. The estimator with the best regression is Fj1 (Equation (8)), which has a value of around 14 for both

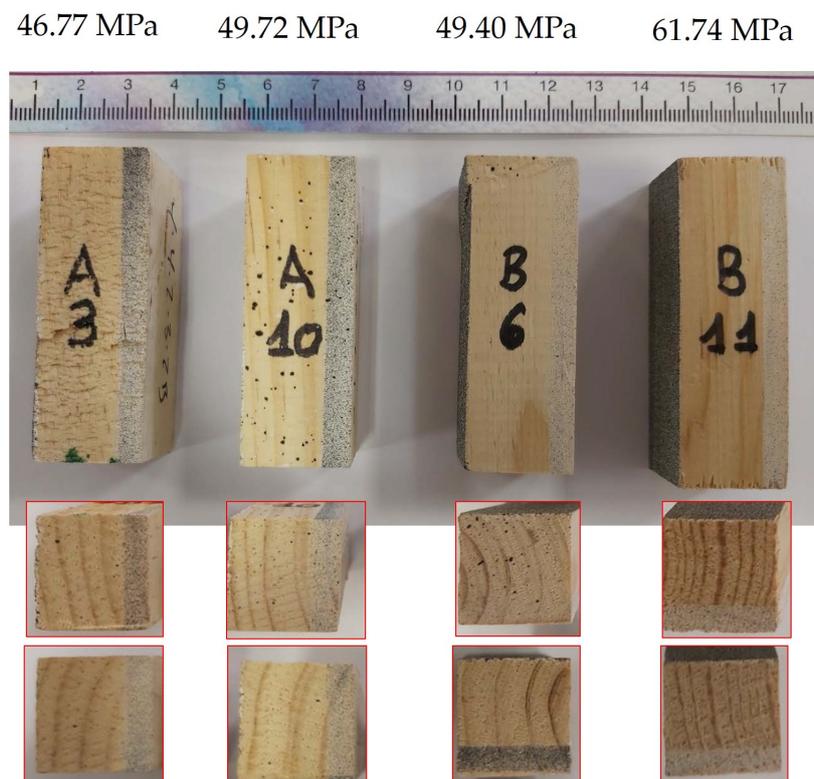
**Figure 14.** Appearance of the specimens selected for traceability.

In addition, four specimens (two of each of the series) were randomly taken with their individual values of compressive strength (Figure 14) to determine the traceability of the samples with the data represented in the graph (Figure 15) and perform a complementary microstructural study (Figures 16–22). Specimens were selected in the high, medium, and low resistance ranges.

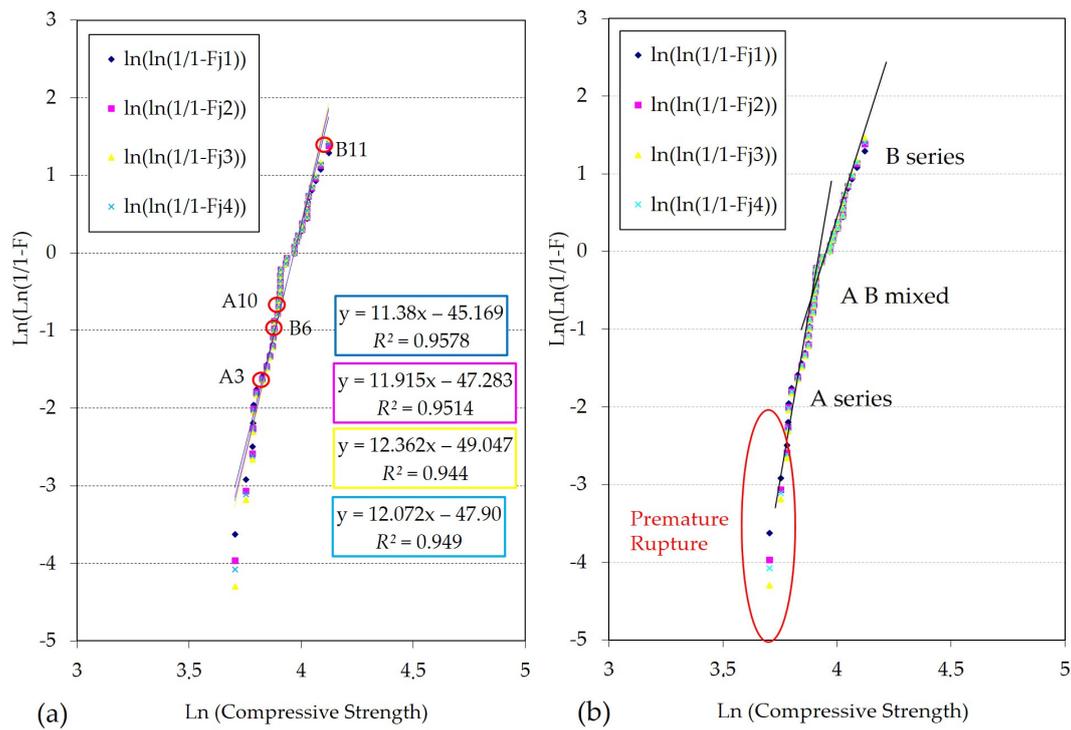
**Figure 15.** Weibull plot for all samples tested: (a) traceability of the selected specimens within the graph and (b) approximate discrimination of the series.

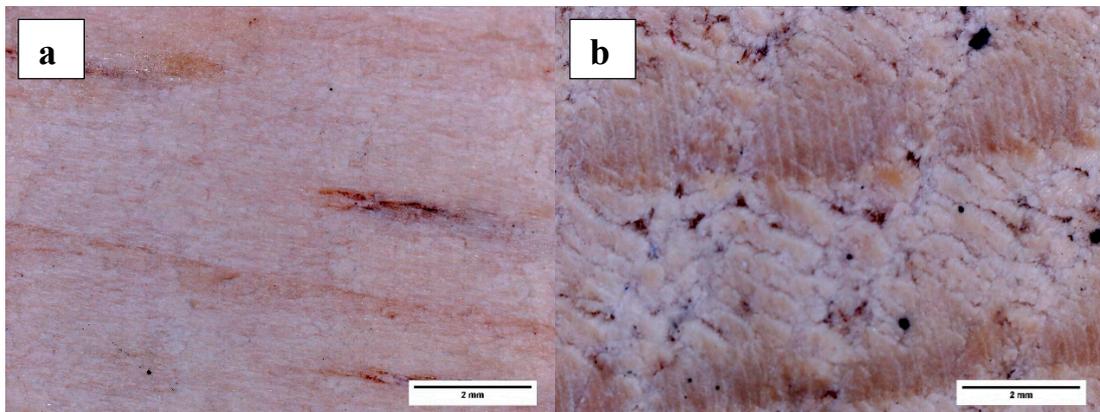
**Figure 16.** Macroscopic appearance of the samples: (a) longitudinal and (b) top view.

As a complement to the strength and reliability study, a microstructural study was carried out on some samples (Figures 16–22), specifically those that were chosen to evaluate the traceability of the Weibull regression. Figure 15 shows the macroscopic appearance of the samples. An example of the surface finish of the specimens is shown in Figure 16a. Figure 16b, in which the fibers can be observed, shows the upper face of the specimens.

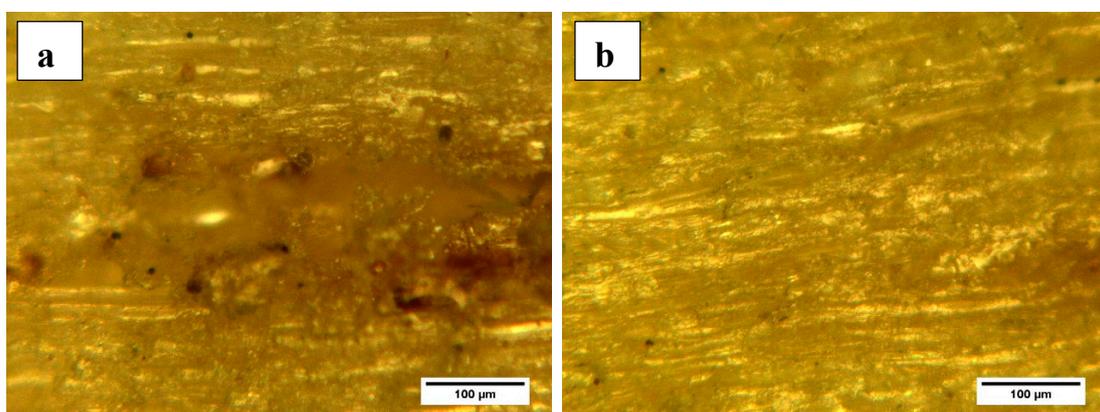
**Figure 17.** Microscopic appearance of the samples: (a) heterogeneity with associated porosity and (b) fiber arrangement.

Figures 17 and 18 show microstructural details of the wood. Figure 16a shows the presence of heterogeneities with the associated porosity. If this type of defect is large, it can reduce the mechanical properties. These defects can remain on the surface, be very small, and have little impact on the strength of the specimen. In contrast, if they remain inside the specimen and are large, they can cause premature failure, without prior notice. Figure 18 shows the type of staggered breakage (at  $45^\circ$ ) of the fibers of the material on the face corresponding to the speckled texture.

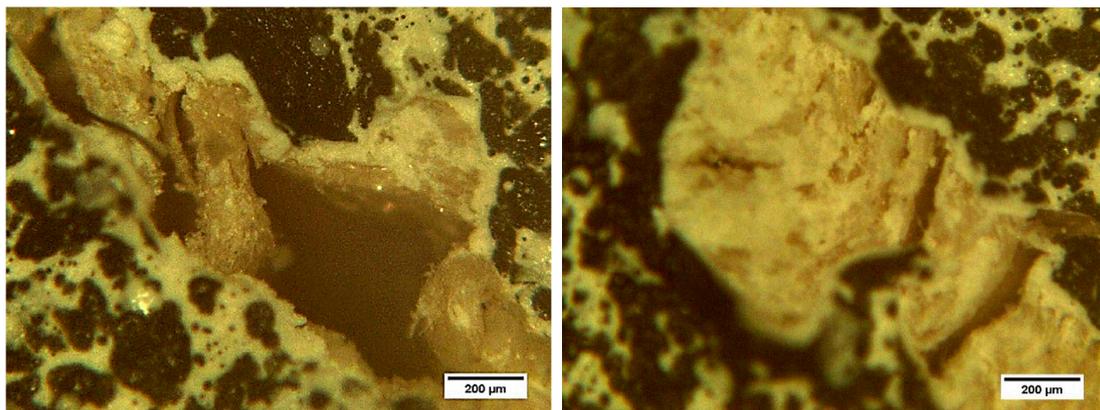
**Figure 18.** Micrographs of the breaking zone of specimen A3 by the speckled zone that was generated at 45°; the consecutive jumps of the fibers are observed.

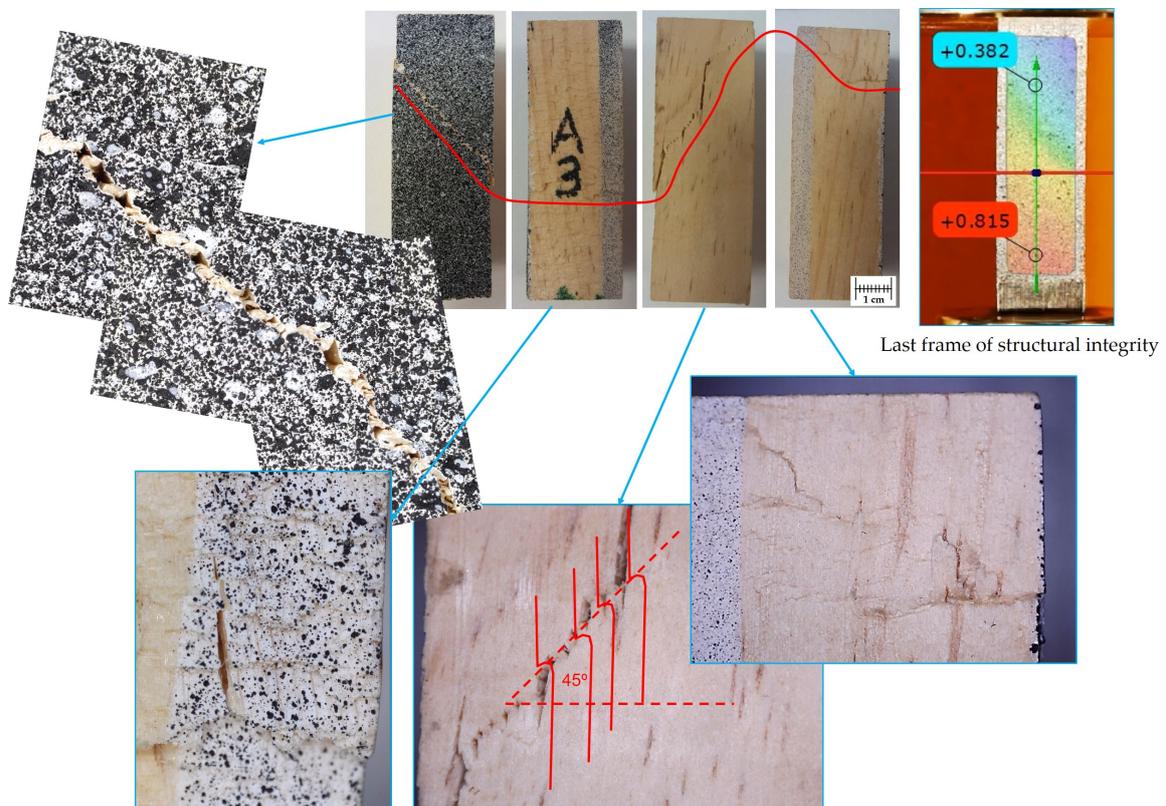
**Figure 19.** Appearance of the damage produced in the specimen A3. Comparison with the last frame of the structural integrity of the sample.

and B6, the typical 45° breakage of the wood is observed. Whereas in A3 (Figure 19) the break occurred in the middle of the piece, in both A10 and B6 it was located in the upper portion. Specimen A3 shows the least resistance, but also underwent a central break at 45°, as shown by the last frame of the piece with structural integrity (without break). Specimens A10 (Figure 20) and B6 (Figure 21) show similar values in terms of compressive strength parallel to the fibers. The macrographic study fully coincides with the resistant behavior offered by the samples: the breaks were similar and both broke in the upper area at 45° angles but with less clarity than in the first case. The last frame shows the upper break, in addition to a mixture of the breaks of the four faces. There was no apparent breakage of the specimen B11 (Figure 22), although it underwent crushing, because this specimen was selected from the sapwood area of the trunk, which presents higher compressive strengths than the middle and heartwood areas (A3, A10, and B6) [47]. Each case is compared with the last frame in which there was integrity in the specimen, i.e., it maintained its shape without breaking. It can be seen how the use of the DIC roughly predicts the break zone a few milliseconds before the sample breaks. In the case of the test piece B11, the forces are distributed along the length of the test piece and, at the end, it recovers, maintaining its parallelepiped shape.

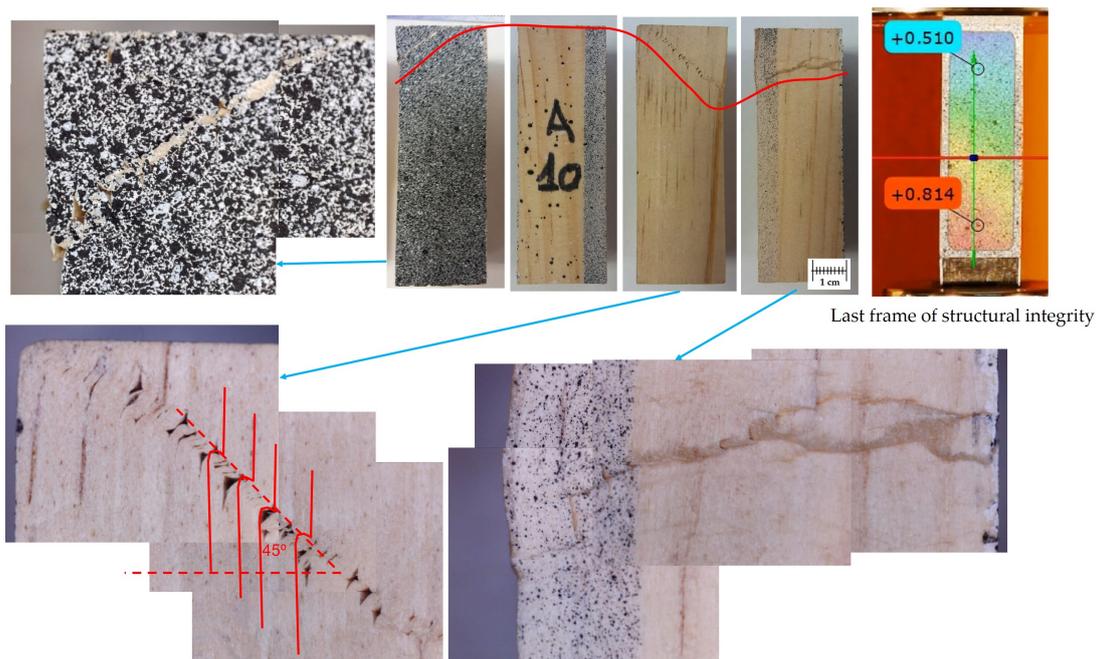
**Figure 20.** Appearance of the damage produced in the specimen A10. Comparison with the last frame of the structural integrity of the sample.

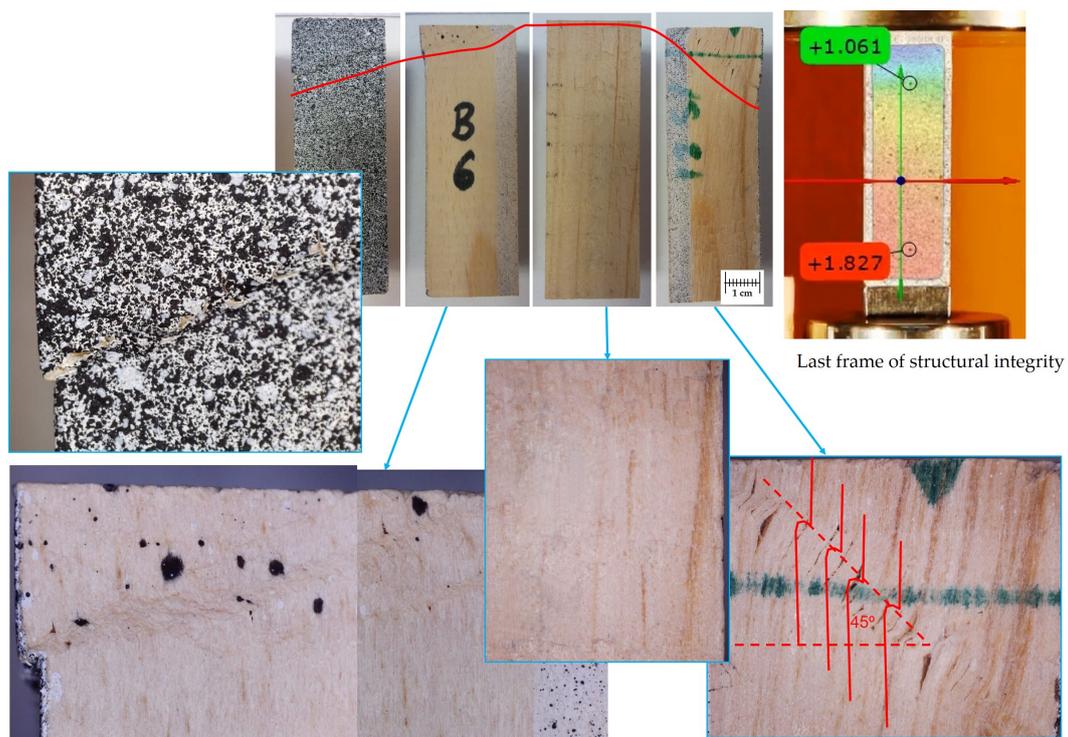
**Figure 21.** Appearance of the damage produced in the specimen B6. Comparison with the last frame of the structural integrity of the sample.

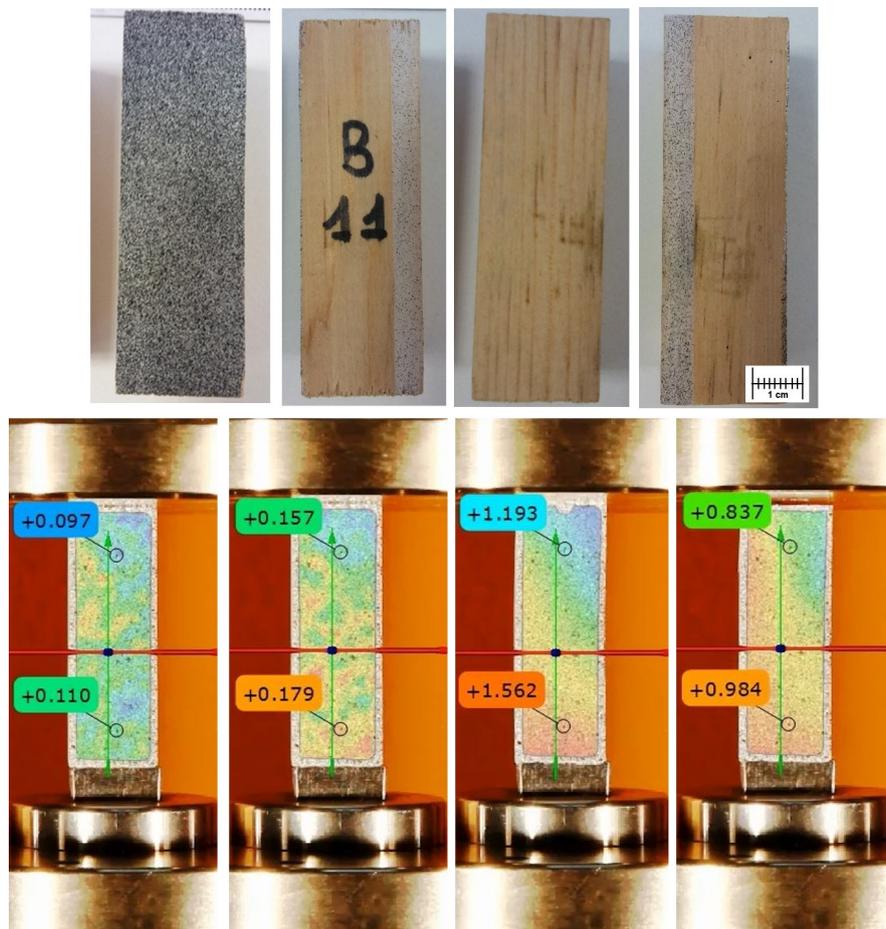
**Figure 22.** Final appearance of specimen B11 (all lateral faces). Frames of the test, in which the latter two show recovery in the elastic zone and separation from the press.
