Article

Utilizing Intelligent Portable Bicycle Lights to Assess Urban Bicycle Infrastructure Surfaces

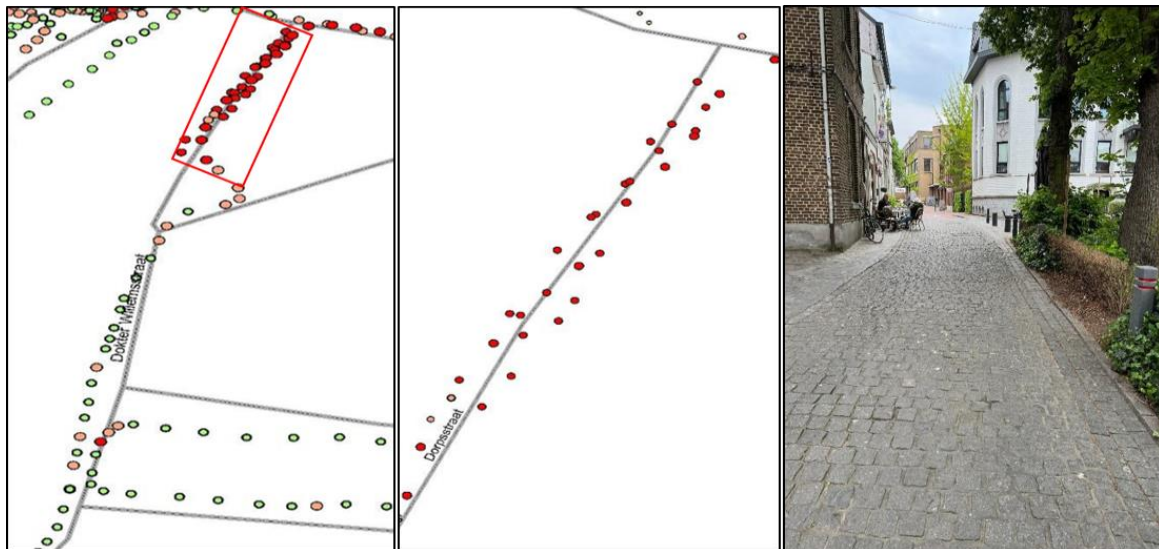
In Figure 8, the left photo represents the first step in analyzing and identifying sections with anomalies. We used the GPS and vibration through a smartphone application utilized with the SEE.SENSE ACE bicycle lights—this way, our measurements are quickly matched with a GPS location value. Hence, by assigning a vibration value to each spatial location, we can identify particular areas of bicycle paths and streets causing the most discomfort to cyclists.

Additionally, with spatial location linked with the vibration, the magnitude can be known at each location, with a red point indicating a greater roughness. The second phase, seen in the center of Figure 8, entails the highest roughness at a specific location. This confirms that this location is where most cyclists are experiencing the most extensive vibrations, making the bicycle street uncomfortable. On the right side of Figure 8 is photographic documentation of the road in this troublesome portion of the street.

Figure 8. Photographic representation of the bicycle street with high vibration.

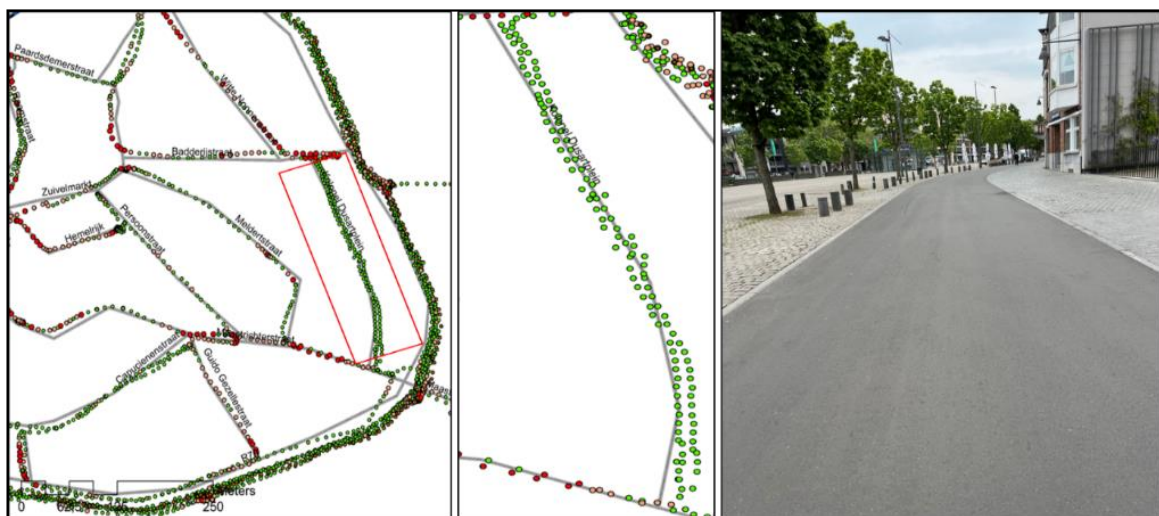
The green points on the map (refer to Figure 7) represent very low vibration. These green points indicate that the bicycle path and streets are relatively smooth. Figure 9 illustrates the vibration in a location where the cyclists experienced minimum vibration recorded.

Figure 9. Photographic representation of the bicycle street with low vibration.

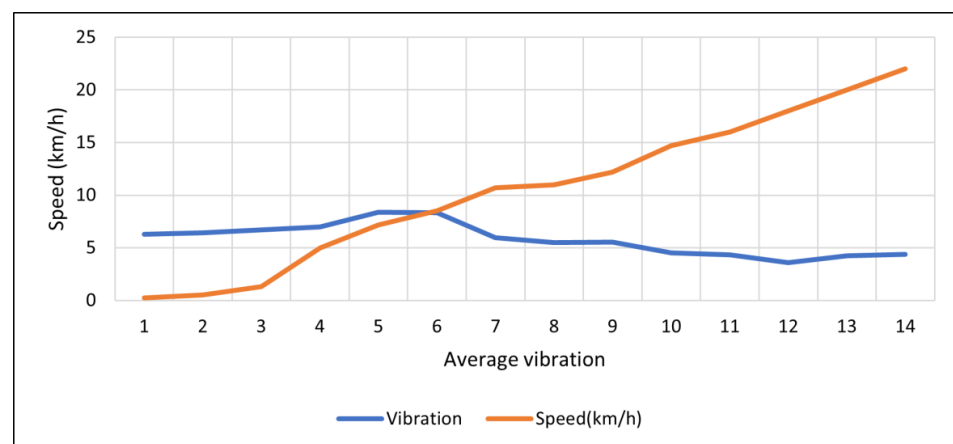
Figure 12 shows that the vibration slightly decreases with an increase in speed. The vibration is higher at a slower speed. This is because the riders tend to slow down when the bicycle path is not smooth or they cannot bike faster on rough pavement. Similarly, the rider opts to cycle at a higher speed when there are no irregularities on the bike path surface.

Figure 12. Speed and vibration correlation.
