# Influence of Acetone and Primer on Strength and Ductility of Chlorinated Poly(vinyl chloride)

Hanlin Mi, Xiaokang Huang and Pean-Yue Ben Jar \*

Department of Mechanical Engineering, University of Alberta, Edmonton, AB T6G 1H9, Canada

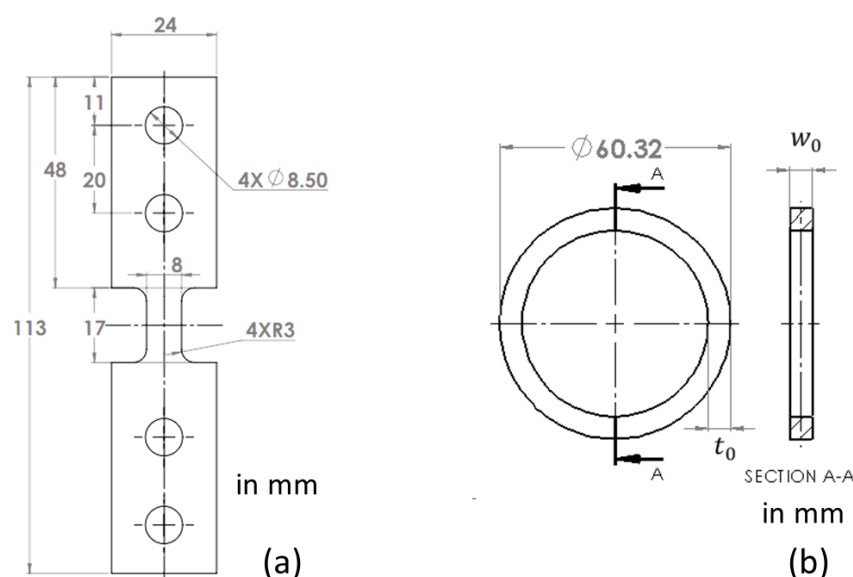
**Figure 1.** Dimensions of specimens used in the study: (a) dog-bone specimen and (b) pipe ring specimen.

Dog-bone specimens were waterjet cut from the CPVC sheets with a gauge section of 11 mm long and 8 mm wide, and the pipe ring specimens from the CPVC pipe with dimensions same as those used previously [13]. Dimensions for these two types of specimens are given in Figure 1.

With the specimen tab length of 48 mm, as shown in Figure 1a, a gap of 6 mm was provided between the grip edge and the edge of the gauge section so that premature fracture due to stress concentration by the gripping could be avoided. For pipe ring specimens, the D-split test setup was used, same as that used previously [13] but without any extensometer attached to the gauge section. This was because the post-immersed specimens with a short drying period of less than 24 h were too soft to support the extensometer. All mechanical tests were duplicated to ensure good reproducibility of the test results.

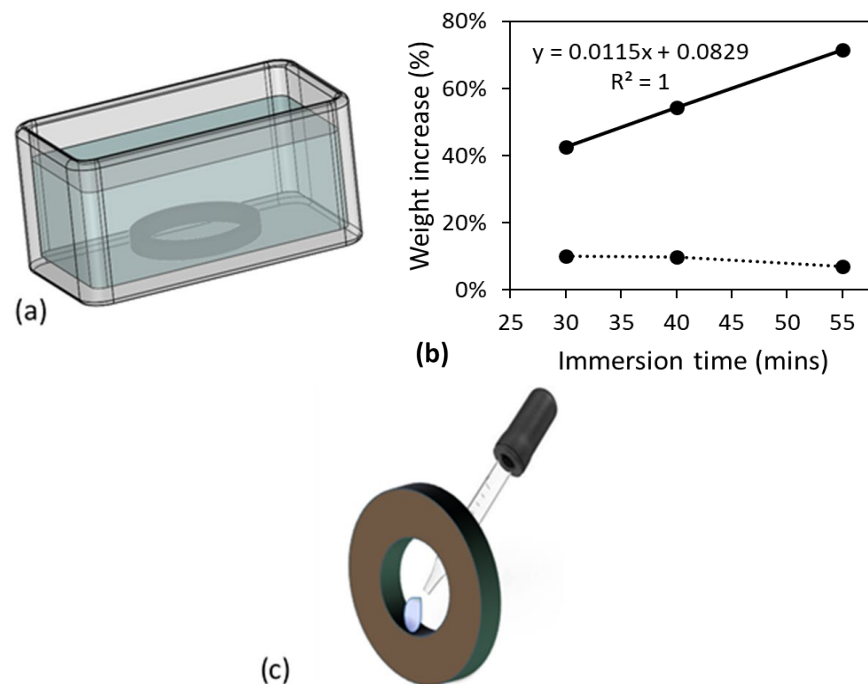
**Figure 2.** Specimen treatment methods used in this study: (a) setup for the immersion treatment, depicted using a pipe ring specimen, (b) weight gain of dog-bone specimens as a function of immersion time in acetone, and (c) local treatment of a pipe ring specimen on its inner surface.

Setup for the immersion treatment was same as that used previously [13], for both dog-bone and pipe ring specimens, as depicted in Figure 2a using a pipe ring specimen as an example. In the immersion treatment, the chemical solvents were replaced when tiny CPVC bits were seen in the solvents, so that the specimens were immersed in the relatively fresh chemical solvents. Since objective for the immersion treatment of dog-bone specimens was to saturate the specimens with the chemical solvents without dissolving the CPVC, the immersion time in primer and in acetone could be different. The immersion time for dog-bone specimens in acetone was determined based on Figure 2b which shows the change of weight gain as a function of the immersion time immediately after the immersion treatment (solid line) and after air dry for 6 h (dashed line). The former suggests that the weight gain increased almost linearly with the increase of immersion time, but the dashed line shows a noticeable drop of the weight gain by the increase of immersion time from 40 to 55 min. Difference of the trend lines for the weight gain suggests that after the immersion in acetone for 40 min, mass loss by dissolving CPVC into acetone outweighed the increase of the acetone absorption. Therefore, the immersion time of 40 min was chosen for the immersion of dog-bone specimens in acetone.

In addition to the immersion treatment, some pipe ring specimens were exposed to acetone or primer in a selected region on the inner surface, as depicted in Figure 2c, using a pipette to drip the chemical solvents in the selected region. Care was taken to make sure that the chemical solvents were only in contact with the specimens in the selected region, and such treatment is referred to as ‘local contact’ in this work. Total duration for the dripping process was 2.5 h for both primer and acetone. For all pipe ring specimens after either the immersion treatment or the local contact on the inner surface, the specimens were air dried for 10.5 days before the mechanical testing.

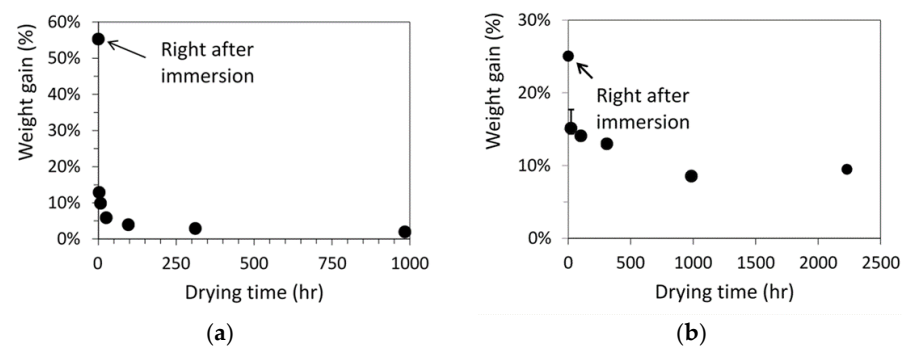
**Figure 3.** Weight gain of dog-bone specimens as a function of drying time after the immersion in (a) acetone for 40 min and (b) primer for 10 min.

Figure 3 summarizes the percentage of weight gain for the dog-bone specimens as a function of drying time after the immersion either in acetone for 40 min, Figure 3a, or in primer for 10 min, Figure 3b. As shown in these figures, initial amount of acetone absorbed in the specimens was more than twice of the amount of primer. However, after the air-dry process, the residual acetone left in the specimens was about 2 wt% of the virgin specimens, much less than the residual primer of around 9 wt%, even though the maximum drying time for the specimens immersed in acetone was less than half of the drying time for the specimens immersed in primer. Note that each point in Figure 3 represents the average value from at least three specimens. Error bars were also included in Figure 3 to indicate the range from minimum to maximum values, but the ranges were smaller than the size of the markers for the average values, except the second point from the left in Figure 3b.

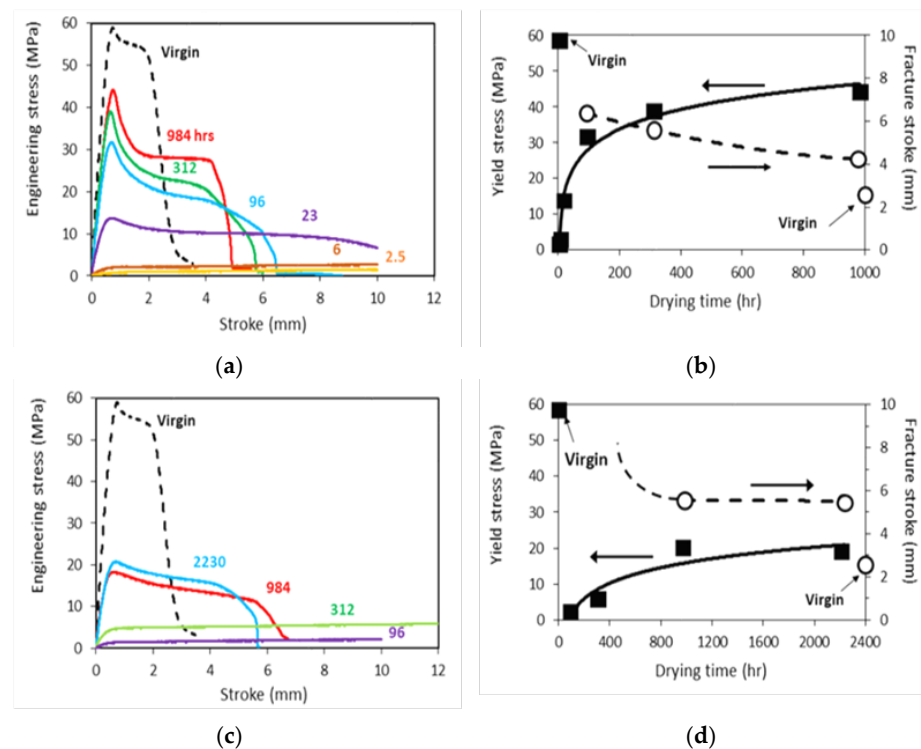
**Figure 4.** Mechanical test results for dog-bone specimens after immersion in acetone for 40 min or in primer for 10 min, and then dried for a period in hours as indicated by the numbers in (a,c): (a,b) in acetone, and (c,d) in primer.

Figure 4 summarizes mechanical test results for dog-bone specimens. Figure 4a,c present the typical engineering stress-stroke curves for specimens with different drying time (as shown by the numbers in each figure), after immersion in acetone and primer, respectively, and Figure 4b,d the corresponding average values for yield stress and fracture stroke, each from two specimens, as functions of drying time, including values for the virgin specimens as a reference. Data in Figure 4 suggest a general trend that yield stress increases and fracture stroke decreases with the increase of drying time. However, after a given air drying period, specimens immersed in acetone showed higher yield stress than specimens treated in primer, filled squares in Figure 4b,d, respectively, and both yield stress values were lower than the yield stress for virgin specimens. As shown in Figure 3, difference of the yield stresses was because both acetone and primer acted as plasticizers for

CPVC. With a lower plasticizer content, drop of the yield stress for the dog-bone specimens was smaller. In addition, after air dry for 984 h, yield stress in Figure 4b was higher than the corresponding value in Figure 4d after air dry for 2230 h. This also suggests that acetone was much easier than primer to remove from CPVC. This is consistent with the change of weight gain shown in Figure 3. That is, residual acetone content was much lower than residual primer content, even though the former was after a shorter air-dry period. Unfilled circles in Figure 4b,d also suggest that ductility change in terms of stroke for the onset of fracture showed the opposite trend to that for yield stress. That is, comparing fracture stroke for specimens treated in primer after air dry of 2230 h, Figure 4d, with those treated in acetone after air dry of 984 h, Figure 4b, the former was larger than the latter even after a longer drying period, and both were larger than that for the virgin specimens (about 2.5 mm). This trend could also be explained by the plasticizer effect and the higher residual primer content than the acetone content.

In addition to the trends for yield stress and fracture stroke in Figure 4b,d, engineering stress–stroke curves shown in Figure 4a,c also indicate that with a short drying time, i.e., less than 6 h in Figure 4a and 312 h in Figure 4c for specimens immersed in acetone and primer, respectively, these curves do not show any peak stress. This suggests that these specimens deformed uniformly through the whole gauge section till the end of test without fracture, and that residual acetone and primer in the specimens were sufficient to act as a plasticizer to allow large deformation without crack initiation. Therefore, degradation was not introduced to CPVC by immersion in these chemical solvents. Note that all mechanical tests, except the curve with drying time of 312 h in Figure 4c, were stopped when the stroke reached 10 mm. Therefore, specimens after drying periods of 2.5, 6 and 23 h in Figure 4a, and 96 and 312 h in Figure 4c did not fracture at the end of the tests.

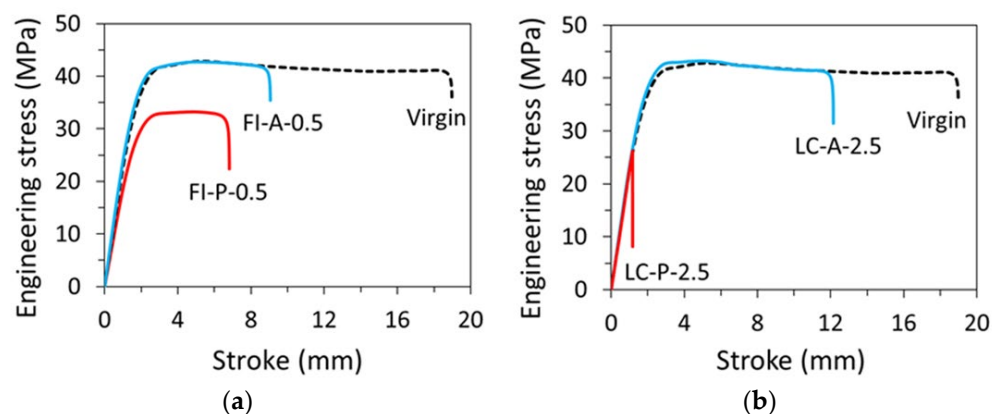
**Figure 5.** Engineering stress–stroke curves for pipe ring specimens: (a) after full immersion for 0.5 h in acetone (FI-A-0.5) or primer (FI-P-0.5) and then air dried for 10.5 days, and (b) after local contact for 2.5 h with acetone (LC-A-2.5) or primer (LC-P-2.5) and then air dried for 10.5 days.

Figure 5 presents typical engineering stress–stroke curves for pipe ring specimens after either the full immersion treatment (FI), Figure 5a, or through the local contact (LC) on the inner surface, Figure 5b. ‘A’ in the curve labels in Figure 5 stands for acetone, ‘P’ primer, and ‘0.5’ and ‘2.5’ time in hours for full immersion and local contact, respectively. For example, the curve labelled as ‘FI-P-0.5’ in Figure 5a was from a specimen after full immersion in primer for 0.5 h. Note that as mentioned earlier, all pipe ring specimens were air dried for 10.5 days prior to the mechanical testing, to be consistent with one of the drying periods used in the previous study [13]. Figure 5 also includes a reference curve (using a dashed line) which was from a virgin specimen without any treatment.

Figure 5a suggests that after the immersion-and-air dry process, the pipe ring specimens treated in primer (FI-P-0.5) had a much lower yield stress than that for the virgin specimens, consistent with the results reported previously [13]. However, for the pipe ring specimens treated in acetone and then air dried for 10.5 days, as shown by the curve FI-A-0.5 in Figure 5a, yielding could occur at the same stress level as the virgin specimens, though ductility in terms of fracture stroke was reduced. The possibility of recovery of the maximum stress to the level for the virgin specimens also suggests that acetone could easily be removed from CPVC, and that the air dry for 10.5 days was sufficient to reduce the acetone content in the pipe ring specimen to a negligible level, to avoid its effect on the yield stress of the material, though a detailed investigation using a large number of specimens would be needed to determine the critical drying time needed after the immersion treatment in acetone to reach a full recovery of the yield stress for the specimens.

The corresponding pipe ring specimens treated through local contact with acetone and then air dried for 10.5 days, as shown by LC-A-2.5 in Figure 5b, also showed the same yield stress level as that for the virgin specimens. However, the corresponding specimens treated in primer and then air dried for 10.5 days, i.e., either FI-P-0.5 in Figure 5a or LC-P-2.5 in Figure 5b, the peak stress was much lower than that for the virgin specimens. As the

curve for LC-P-2.5 in Figure 5b shows a sudden drop of the engineering stress while the curve was following the path of load increase of the virgin specimen, and the specimen fractured in a brittle manner, the LC-P-2.5 specimen was fractured before yielding could be generated. Although the change from a ductile, post-yield fracture for the virgin specimens, to the brittle, prior-to-yield fracture after the treatment in primer could be interpreted as a ductile-brittle transition, it needs to be pointed out that the specimens with the ‘local-contact’ treatment could not be fully saturated with the primer on the cross section where the local contact with primer was made. Rather, primer was partially absorbed on the cross section and thus, the cross section had a two-layered structure in which only the layer close to the inner surface contained primer [13]. In view of such a two-layered structure on the cross section, rather than referring this change of fracture behavior as a ductile–brittle transition, other possible reasons for its occurrence, such as the interaction between the relatively soft, low strength inner layer and the stiff, high strength outer layer, should be considered. Only after these reasons are ruled out could we consider this phenomenon as a ductile-brittle transition. Note that both plots in Figure 5b for specimens after the local contact treatment also indicate that after the drying period of 10.5 days, initial slope of the engineering stress–stroke curves became similar to that for the virgin specimens, suggesting that after air dry of 10.5 days, the inner layer in both LC-P-2.5 and LC-A-2.5 has gained sufficient stiffness to show little effect of the residual chemical solvents on the overall specimen stiffness.

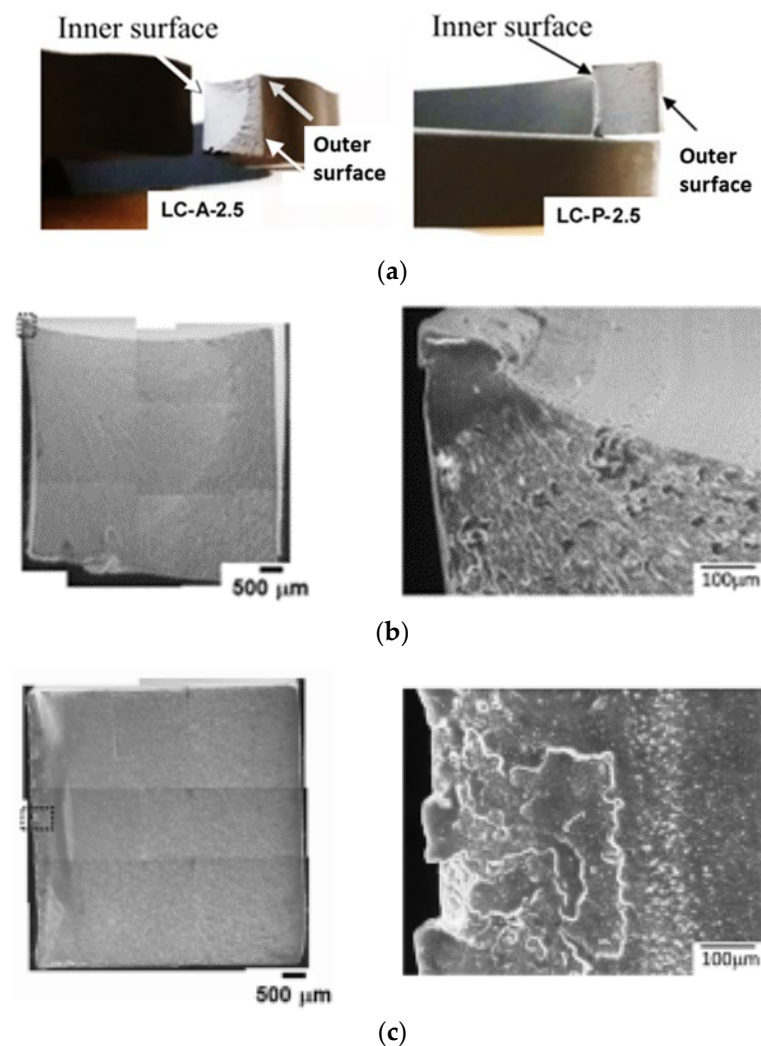
**Figure 6.** Fracture surfaces of pipe ring specimens after the treatment through local contact on the inner surfaces: (a) optical photographs showing the overall fracture surfaces, (b) SEM micrographs from an LC-A-2.5 specimen, and (c) SEM micrographs from an LC-P-2.5 specimen. For micrographs in (b,c), inner surface is on the left, and outer surface on the right.

To further investigate the fracture behavior of the pipe ring specimens treated through local contact with either primer or acetone on the inner surface, fracture behaviors of these specimens were inspected microscopically, as presented in Figure 6. Figure 6a presents optical photographs, showing the overall fracture surfaces before the SEM examination. The left photograph in Figure 6a was from a post-tested LC-A-2.5 specimen, showing a fan-shaped area that was generated from a corner near the inner surface, and the right photograph from LC-P-2.5, showing a narrow band along the vertical direction, generated across the edge along the inner surface.

The corresponding SEM micrographs for Figure 6a are shown in Figure 6b for LC-A-2.5, and Figure 6c for LC-P-2.5. Left micrographs in Figure 6b,c are composite micrographs, by combining many SEM micrographs at the same magnification to show the overall fracture surfaces. SEM micrographs of relatively high magnification for the regions boxed in the left composite micrographs using dash lines, are presented on the right of Figure 6b,c, depicting the flat crack initiation zones which do not show any sign of crack initiation from a dominant defect. This is an indication of ESC [14]. Since crack initiation in LC-A-2.5 started after the yielding, but that in LC-P-2.5 before, as indicated by the relative stroke position for the sudden stress drop with respect to the stroke for the maximum stress, the region where crack was initiated in the former was smooth while that in the latter consisted of multiple flat regions with slightly different elevations.

Another difference between Figure 6b,c is the extent of stable crack growth before the transition to relatively fast crack growth. The left, composite micrograph in Figure 6b shows that the crack started from a corner of the cross section near the inner surface, which grew in a stable manner to form a fan shape with area covering more than half of the cross section before the fast growth. The corresponding micrograph in Figure 6c, on the other hand, shows crack initiation along the edge adjacent to the inner surface, which led to fracture through a relatively fast crack growth, resulting in a sudden stress drop shown by the curve of LC-P-2.5 in Figure 5b. Features on the fracture surfaces to indicate ductile and brittle behaviors and the transition from stable to fast crack growth have been well documented in Ref. [15]

Note that the fan-shaped region shown in the left micrograph of Figure 6b is consistent with the observation reported previously, i.e., Figure 9a in ref. [13] for dry (virgin) specimens. This suggested that after a drying period of 10.5 days, LC-A-2.5 could fracture in a manner similar to the virgin specimens.

For LC-P-2.5, the absorption of primer through the inner surface (i.e., the left edge on the cross section of Figure 6c) resulted in a left part of the cross section with a reduced yield stress. Although Figure 4d suggests that decrease of yield stress could be accompanied by the increase of fracture ductility, the fracture surface shown in Figure 6c suggests that crack started from the region of low yield stress. Therefore, it is speculated that the high fracture ductility of the region has been suppressed by the adjacent region that has high yield stress and low fracture ductility. Growth of the crack to the adjacent region of high yield stress and low ductility resulted in the brittle fracture. Godart and Leever [16] discussed possible fracture scenarios in a bi-layered polymer structure. However, the discussion was focused on the crack initiation in the thin, brittle layer, and crack growth into the tough substrate to result in a brittle fracture, rather than the ductile fracture for the pure substrate without the thin, brittle layer. To our knowledge, the scenario of crack initiation from the region of low yield stress and high ductility has not been investigated in the past. We speculate that ductility of the low yield-stress layer is suppressed due to its bonding to the high

Results from the pipe ring specimens presented in Figure 6 also suggest that after the exposure to primer, the specimens show a bigger reduction in strength and ductility than those exposed to acetone. Therefore, if excessive amount of primer was applied in the solvent welding process, to result in primer on some inner surface of the pipe which was not covered by adhesives, there could be an adverse effect on the mechanical properties of the CPVC pipe. In other words, primer applied in solvent welding process could actually reduce the load-carrying capability of the CPVC pipe. Although in the bonding assembly, reduction in the mechanical performance of CPVC could be offset by the load-carrying enhancement from the matching counterpart, such an offset benefit does not exist for the CPVC pipe section that is in contact with the excessive primer and is not part of the bonding assembly. This scenario could not be avoided, especially in an environment of low temperature or in a welding process that needs a relatively long time to complete, resulting in decrease of strength and ductility of CPVC. This could lead to generation of micro-cracks from the inner surface of the pipe, especially for pipes with a relatively high residual stress [17] or made of CPVC resin of relatively low molecular weight. These micro-cracks could evolve over time to cause premature pipe failure.
