# Activated Carbon-Spinels Composites for Waste Water Treatment

## Supplementary Materials:

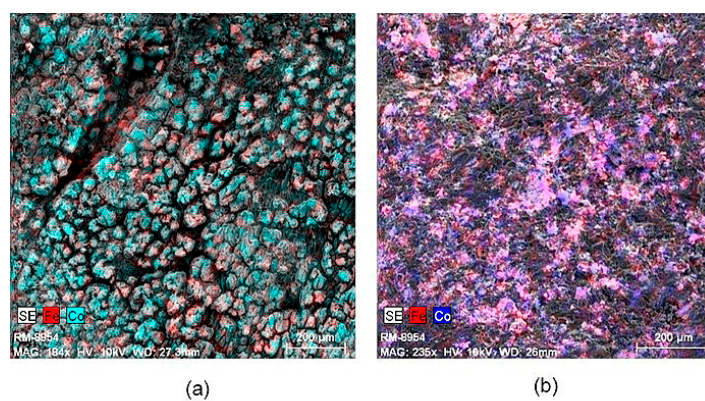
**Figure S1.** SEM images of  $\text{CoFe}_2\text{O}_4/\text{AC1000}$  composite calcined by secondary electrons detector (SE) a 235x. (a) Before the acid wash; (b) after acid wash.

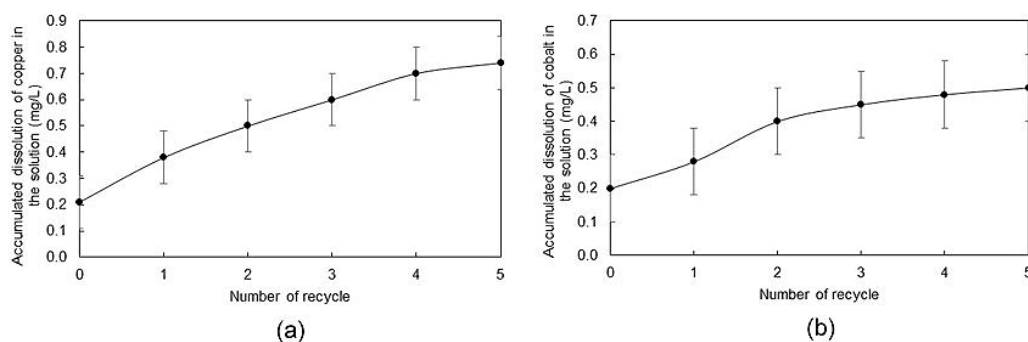
**Figure S2.** Accumulated dissolution of copper and cobalt in the cyanide solution after five oxidation essays.
