# Seismic Upgrading of a Historical Masonry Bell Tower through an Internal Dissipative Steel Structure

Arianna Pavia , Fabrizio Scozzese , Enrica Petrucci and Alessandro Zona \*

Abstract: Masonry towers are part of a valuable architectural heritage characterizing the landscape of many historical areas. These towers are vulnerable structures that are prone to earthquake damage. Hence, the design of effective seismic upgrading interventions is an important task for preserving such architectural forms for future generations. In view of that, the objective of this study is to contribute a possible addition to the portfolio of available approaches for seismic upgrading of masonry towers. This goal was pursued by exploring an innovative structural solution that does not alter the external appearance of the tower and its static scheme under gravity loads, yet is able to increase its capacity to withstand seismic actions through added damping. Specifically, the proposed solution consists of a steel structure internal to the masonry tower that incorporates fluid viscous dampers. In order to evaluate its potentialities, a real case study was taken as a testbed structure, historic analysis

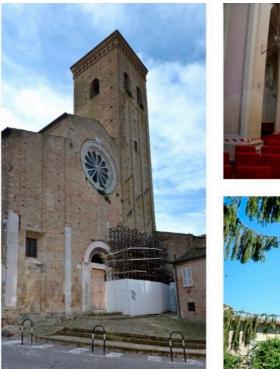
Figure 1. External and internal views of the Church of San Zenone (Fermo, Italy) with its bell tower.

The case study considered in this article is the bell tower of the Church of San Zenone (Figure 1) in Fermo, a town in the Marche region (Central Italy) that is characterized by historical stratification dating back to the Roman age including medieval transformations and reconstructions.

In 2012, the Church was reopened for worship after 35 years and following restoration works, and became the official seat of the Order of the Knights of Malta. Following a number of seismic events in Central Italy on 30 October 2016, the Church suffered substantial damage, which mainly affected the bell tower. Provisional measures were taken to secure the bell tower from the risk of collapse (see left-hand-side picture in Figure 1).

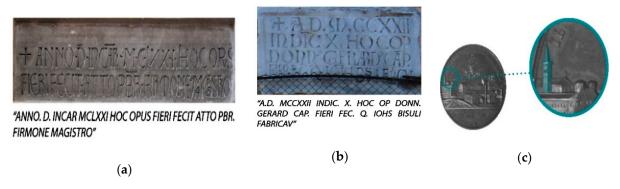
**Figure 2.** (a) Walled inscription inside the Church; (b) inscription placed above the rose window; and (c) commemorative coin depicting the roof of the bell tower.

- (2) (1171)—The in-office bishop demolished the church and the construction of the Church of San Zenone began, as attested by a walled inscription inside the church (Figure 2a). The main entrance portal was realized with features that can still be appreciated today.

- (3) (1222)—Refurbishment of the construction, as attested by the inscription placed above the rose window (Figure 2b); the church was given a new configuration with three naves, each ending with a semicircular apse. New single lancet windows were made in the clerestory, to provide light inside, as well as a large rose window made of white stone.

- (4) (1422)—Construction of a bell tower, located to the right of the main facade. The bell tower is square in plan and was built using brick masonry, punctuated by half pilaster, small arches and the single lancet windows of the bell cell. The cuspidate roof (as depicted in a celebratory coin in Figure 2c) was damaged because it was repeatedly struck by lightning and thus it was rebuilt between 1624 and 1634.

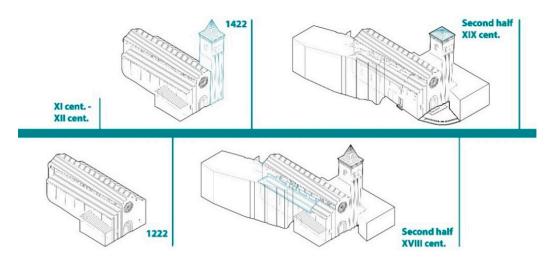
Figure 3. Timeline of the San Zenone Church, from the XI Century to the Second half of XIX Century.

Historical analyses using available bibliographic and archival sources [55–61] as well as the analysis of the stratigraphy and wall apparatus allowed us to trace the transformations of the asset over the centuries. The main construction phases of the church can be summarized as follows (see also Figure 3):

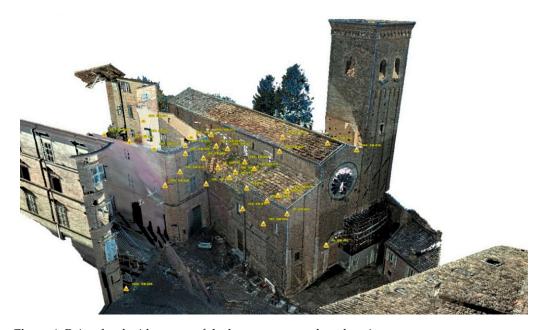
Figure 4. Point cloud with targets of the laser scanner and total station.

The geometric survey was carried out by high definition surveying (HDS) methodology using the Leica ScanStation C10 terrestrial laser scanner, whose performance has an accuracy of 4 to 6 mm (the point cloud thus obtained consists of 36 scans and is of medium density). These data were cross-referenced and georeferenced with the topographic base obtained by total station. The cloud of the points obtained (Figure 4) made possible the geometric and architectural drawings of the architectural asset, both for the exterior and for the interior, and allowed the highlighting of the material and decorative components. In this way, we obtained an in-depth and accurate rendition of the geometry of the current state of the entire complex (bell tower included).

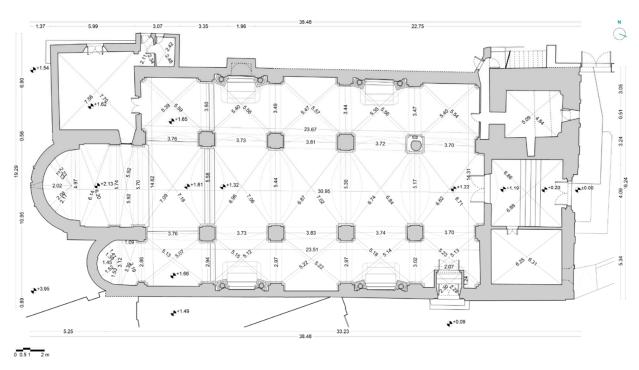
**Figure 5.** Geometric plan of the whole building at 4.00 m height.

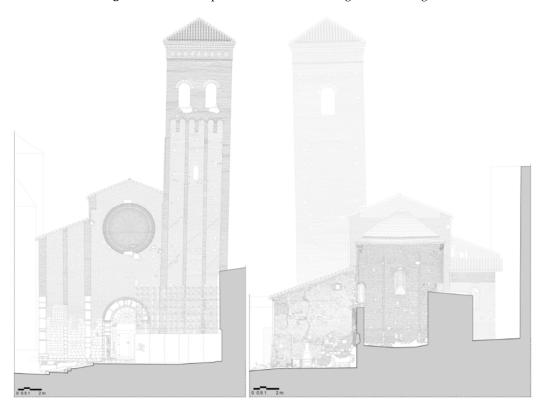
Figure 6. Northern facade and Southern back side of the church (architectural survey).

The church (Figures 5–7) stands on three naves, the main and the left side ending with apses, while the right side ends with a square-shaped sacristy. The dimensions are: 46 m in length, 19.29 m in width and a height of 12.31 m for the side aisles and 15.36 m for the central nave. The bell tower (Figure 8) located on the right side of the main elevation, measures  $6.26 \times 6.33$  m<sup>2</sup> in plan and 29.13 m in height. From the access atrium to the main altar the altitude jump is 2.22 m.

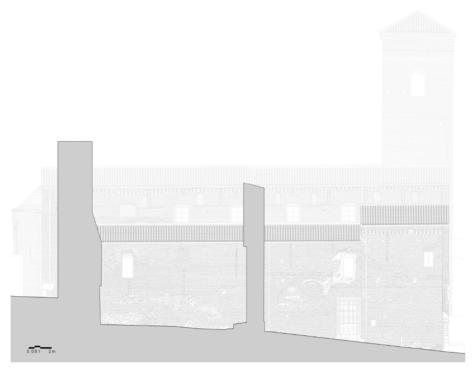
Figure 7. Eastern prospect of the building (architectural survey).

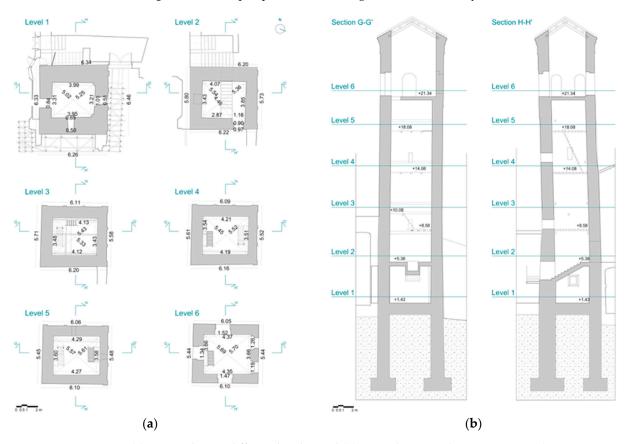
Figure 8. (a) Tower plans at different heights and (b) vertical sections (geometric survey).

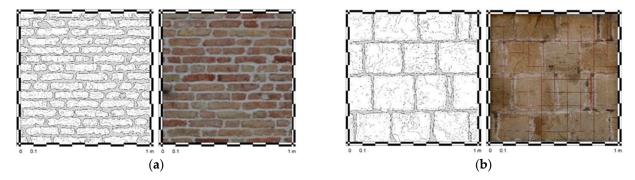
**Figure 9.** (a) Masonry sample of upper part North front, bricks and mortar and (b) masonry sample of lower part North front, sandstone and mortar.

Further studies carried out on masonry samples highlighted the modifications that had occurred on the structural complex over the centuries, thus, confirming the historical-critical reading provided in Section 2.1. Moreover, the studies helped to identify the following two different masonry typologies that characterize the building: bricks and mortar at the upper part of the North fronts, including the bell tower (Figure 9a); and

sandstone blocks and mortar at the bottom of the main elevation (Figure 9b), which belong to the early construction phases of the church.

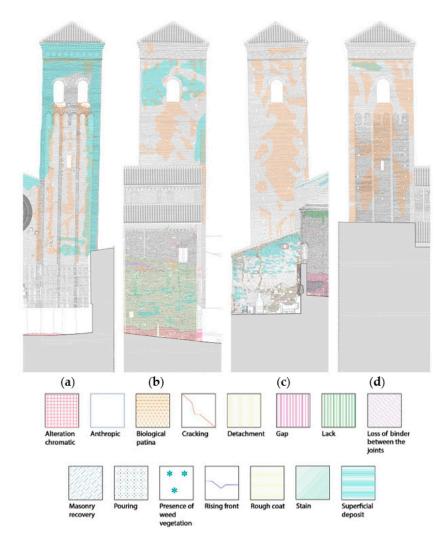
Figure 10. Bell tower decay: (a) front North; (b) front East; (c) front South; (d) front West.

The analysis of decay pathologies was made using the glossary Nor.Mal 1/88 [62]. The exterior of the asset has rather widespread decay phenomena, mostly related to the moisture rising from the ground. Besides humidity, other phenomena are observed, such as superficial deposits, biological patina and the presence of weeds, which also largely affect the bell tower (Figure 10).

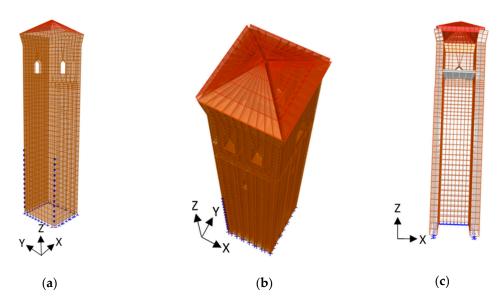
**Figure 11.** Bell tower finite element model: (a,b) 3D views with boundary conditions highlighted in blue; (c) front view (XZ plan), in which the tilted geometrical configuration can be appreciated.

A three-dimensional finite element model (FEM) of the tower was developed in SAP2000 v.20 [72]. The masonry walls were modelled through four-node thick shell elements, thus accounting for transverse shear deformation according to the Mindlin-Reissner formulation [73]. The in-plan geometry of the tower was accurately reproduced as well as the variation in the wall thickness and the openings along the height of the structure (Figure 11). The tilted configuration (almost 2° with respect to the vertical) of the tower was also modelled. Concerning the boundary conditions, the base of the tower was assumed to be fixed. The presence of the adjacent building was considered in the model by following a simplified approach [74,75], according to which the portions of the structure at which the interference is expected are restrained along specific degree of freedom by means of proper supports. It was assumed that the walls of the adjacent building (the main façade of the church and the inner parallel wall) only affect the tower motion along the X direction, hence a set of simply supports effective in X were distributed at a height of 10.00 m along the two corners of the tower (as shown in Figure 11a). The equivalent height of 10.00 m was set based on the consideration that the part of the façade up to the rose window inferior level (up to 10.00 m from the base) is sufficiently rigid to affect the dynamic behavior of the tower, whereas the upper part is more deformable and thus it is neglected in terms of boundary conditions. It is also worth noting that other approaches could be used to account for such structural interaction (e.g., modelling of the entire adjacent walls [74-76], fictitious elements with equivalent stiffness [74–77], equivalent springs [78], upper/lower bound analysis [74–76]), however, the adopted approach is considered suitable, especially given

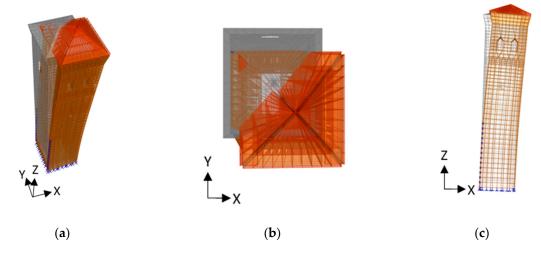
Figure 12. First vibration mode shape of the tower (T = 0.884 s): (a) 3D view; (b) top view; (c) front view.

The structural model was used to analyze the modal properties of the bell tower, thus, helping us to understand the dynamic behavior of the system before the retrofit intervention. The former three modal shapes are graphically shown in Figures 12–14, whereas the other modal parameters (periods T, modal participating mass ratios R) are collected in Table 1 for all the modes needed to achieve the dynamic activation of the 85% mass. Based on these results, the following observation can be made: (i) the first two modes are translational (first mode along Y with  $R_Y$  = 44%, second mode along X with  $R_X$  = 32%) with a slight coupling ( $R_{Y/X} \approx 18\%$ ) between the X and Y directions; (ii) the third mode is purely torsional ( $R_Z$  = 65%); and (iii) 85% of the mass activation along Y is achieved with 10 modes, while 18 modes are required along the X direction. Accordingly, a total of 18 modes were used to perform the dynamic analyses discussed below.

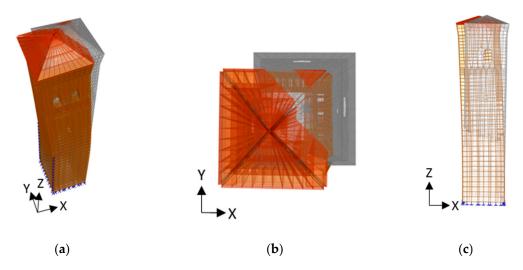
**Figure 13.** Second vibration mode shape of the tower (T = 0.666 s): (a) 3D view; (b) top view; (c) front view.

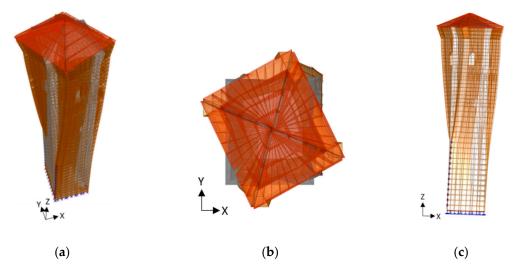
**Figure 14.** Third vibration mode shape of the tower (T = 0.295 s): (a) 3D view; (b) top view; (c) front view.

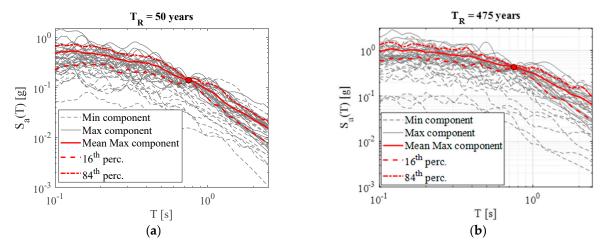
**Figure 16.** Response spectra of both horizontal components of the seismic samples at two intensity levels: (a)  $T_R = 50$  years and (b)  $T_R = 475$  years.

Two reference intensity levels were considered, corresponding to different limit states [79]: the damage prevention limit state, with return period  $T_R = 50$  years, and the life safety limit state, with  $T_R = 475$  years, which are highlighted by colored markers in Figure 15. A set of 20 pairs of earthquake samples was selected at each of the aforementioned IM levels, and the response spectra of both the horizontal components of the seismic input (conditional to the two intensity levels) are depicted in Figure 16. In particular, spectra of the 20 pairs of individual samples are depicted by thin grey lines, continuous for the maximum components (with respect to which the conditioning procedure is operated) and dashed for the minimum ones; the mean and the 16th and 84th percentiles of the maximum spectra are also shown with red lines (a continuous line for the average, a dashed line for the 16th percentile, and a dot-dashed line for the 84th percentile). The life safety limit state was used to perform numerical seismic simulations and investigate the effectiveness of the retrofit strategy.

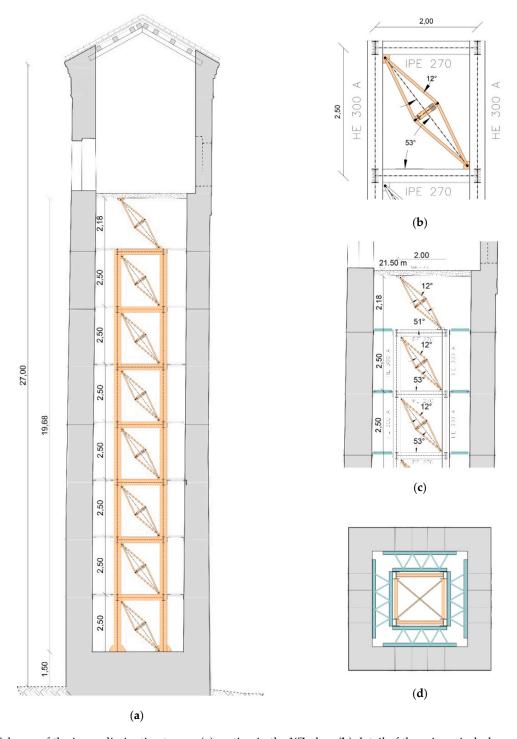
**Figure 17.** Scheme of the inner dissipative tower: (a) section in the XZ plan; (b) detail of the scissor-jack-damper configuration within the inner steel tower; (c) XZ plan view; and (d) in-plan view (XY) of the connections between the inner and outer tower.

The steel structure of the inner tower has the role of hosting the viscous devices and transferring the motion of the outer tower. For this reason, the structure does not need to be rigid, on the contrary, it is designed to be as flexible as possible in order not to alter the dynamic behavior of the masonry bell tower. The inner tower is made of four HEA 300 (European standard wide flange H-section [82]) columns continuous from the ground to the top with the strong axis oriented along the Y direction, which is the most deformable direction. Beams are made of IPE 270 (European standard narrow flange I-section [82]) profiles, with webs linked to the columns through bolted connections working as hinge restraints. In this way, the inner tower stiffness is basically governed by the four columns, working like cantilevers. As can be observed from Figure 17, the frame structure of the inner tower is actually arrested one level below the bell chamber floor. Indeed, the latter set of scissor-jack dampers is directly connected from the top of the inner tower to the bottom of the reinforced concrete slab. The connection between the inner and the outer tower is realized through a strut-and-tie steel system (Figure 17c,d) that is able to rigidly connect the towers in the horizontal plan by uniformly distributing the stresses (generated from viscous devices) on the masonry structure. At the same time, the connection is sufficiently flexible to accommodate the relative rotations arising from the dynamic motion without undergoing bending.

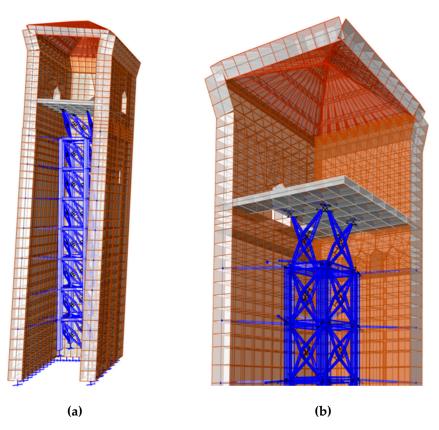
**Figure 19.** Inner and outer tower finite element model: (a) global view; (b) detail of the steel tower connection to the reinforced concrete slab.

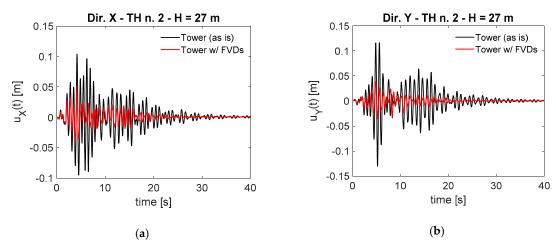
**Figure 20.** Maximum displacement time series for the nonlinear dynamic case of analysis time history (TH) n. 2. Response comparison before and after retrofitting: (a) X direction; and (b) Y direction.

A comparison between the seismic performance before and after retrofitting was done using the following methods: a direct comparison of the response time history in terms of displacements and absolute accelerations; charts of the maximum response quantities at different levels of the tower; and charts of the maximum stresses on the masonry structure. The response time series of the displacements along X and Y are shown in Figure 20. The node monitored was placed at the top of the tower (H = 27 m, as shown in the scheme of Figure 17) and the case of analysis time history (TH) n. 2 was considered. As can be observed, the response after the retrofit intervention is almost halved with respect to the original structure. For the same node, the response time series of the absolute accelerations are plotted in Figure 21, this time referring to the case of analysis TH n. 7. Again, it can be observed that the response of the retrofitted tower is notably reduced.

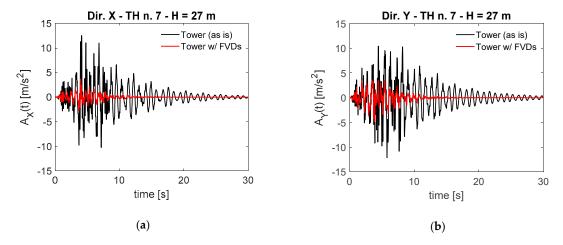
**Figure 21.** Maximum absolute acceleration time series for the nonlinear dynamic case of analysis TH n. 7. Response comparison before and after retrofitting: (a) X direction; and (b) Y direction.

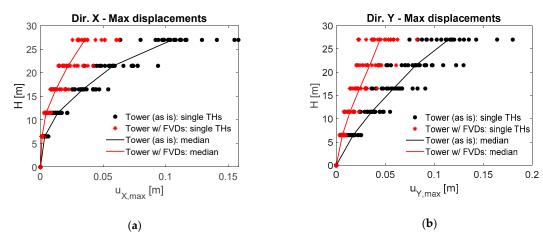
**Figure 22.** Maximum displacements along the height of the tower, before and after retrofitting: (a) X direction; and (b) Y direction.

The efficiency of the proposed retrofit strategy is more systematically assessed in the following charts. In Figure 22, the maximum displacement profiles along the height of the tower, before and after retrofitting, are compared. In particular, the responses of single time-

history analyses (THs) are plotted by colored markers (black dots for the "as is" structural system, red stars for the tower with FVDs), while the median trends are superimposed by using solid lines (black and red, based on the predefined colors convention). According to the presented results, the following comments are provided: (1) limited displacements are observed over the first 10.00 m along the X direction (both with and without FVDs) because of the retaining effect exerted by the adjacent building; (2) the dissipative tower (with FVDs) is effective in reducing the structure's seismic deformation, in both X and Y directions; and (3) the median maximum top displacement experienced by the tower with FVDs is approximately 0.04 m, about 55% less than that of the non-retrofitted tower. Moreover, although a more refined nonlinear model would be required to properly assess the damage state of the tower, some preliminary comments can be provided based on the interstory drift values resulting from the numerical simulations. Indeed, at the maximum tower deformation, a median maximum drift value of about 0.01 is observed on the tower before the intervention, whereas in the retrofitted conditions this value is reduced to 0.004, with the latter value conventionally assumed to characterize the shear strength limit capacity of masonry structures (0.006 is usually related to the flexural capacity) [79].

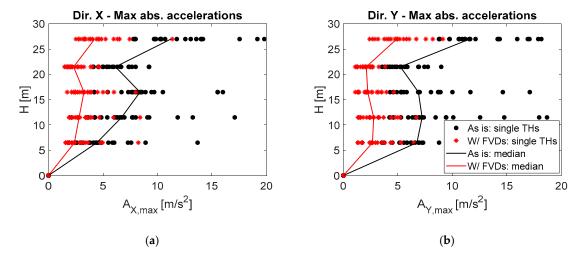
**Figure 23.** Maximum absolute accelerations along the height of the tower, before and after retrofitting: (a) X direction; and (b) Y direction.

In Figure 23, the maximum absolute acceleration profiles along the height of the tower, before and after retrofitting, are compared. The same colors and notation presented above are used. Based on these charts, the following comments are provided: (1) the dissipative tower (with FVDs) is effective in reducing the structure seismic-induced absolute accelerations at all levels, in both the X and Y direction; (2) the abrupt rise observed above the 21.50 m is due to the dissipative tower interruption at that level, therefore the whole mass deriving from the roof and the bell chamber is not directly linked to the dissipative steel tower; and (3) nevertheless, the upper part of the tower can benefit as well from the reduction in demand that results from the devices' energy dissipation.

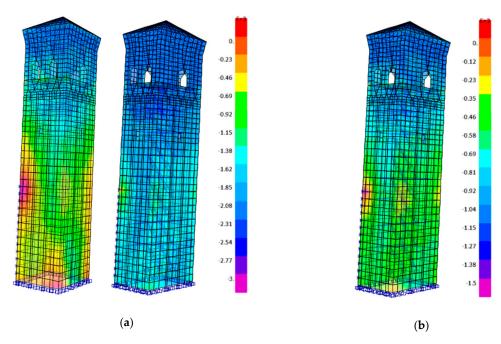
**Figure 25.** Contour plot of  $S_{22}$  (vertical compression) stress values: (a) tower before and after retrofitting shown together by using the same contour interval ([-3000, 0] kN/m<sup>2</sup>); (b) tower after retrofitting shown alone with a specific contour interval setting ([-1500, 0] kN/m<sup>2</sup>). Results were derived from nonlinear dynamic analysis TH n. 2.

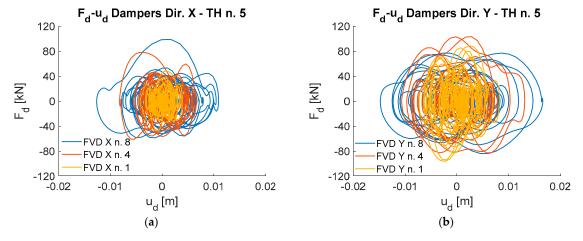
**Figure 26.** Force-deformation cycles for dampers located at different levels of the inner tower. Nonlinear dynamic analysis TH n. 5: (a) X direction; and (b) Y direction.

To conclude the presentation of the results with the life safety limit state, several dampers' force-deformation hysteresis cycles are presented in Figures 26 and 27, for dampers located at different levels of the inner tower (i.e., levels 1, 4, 8) and in both X and Y directions. The cycles shown in Figure 26 stem from the nonlinear dynamic analysis TH n. 5, and those of Figure 27 are from TH n. 17.

The following observations can be made: (1) the amplitude of the loops is influenced by the specific TH due to record-to-record variability among the earthquake samples, despite being conditional on the same intensity levels (in particular, the spectral content variability is responsible for such differences, being devices velocity-dependent); (2) the stroke is higher in dampers at higher levels, as expected; (3) cycles in the Y direction are generally wider because of the higher deformability of the tower along this direction (no adjacent buildings interference); (4) forces produced by the dampers are not very large, therefore they may be well resisted by the tower by exploiting a proper connection system (also able to uniformly distribute the forces); and (5) strokes are compatible with the scissor-jack configuration without inducing a complete alignment of the rods of the crank mechanism.

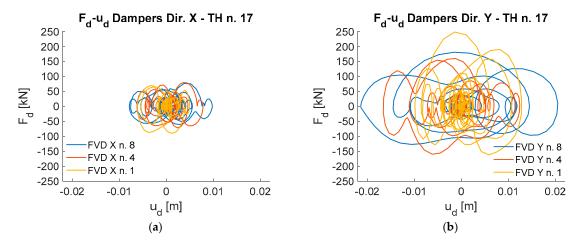
**Figure 27.** Force-deformation cycles for dampers located at different levels of the inner tower. Nonlinear dynamic analysis TH n. 17: (a) X direction; and (b) Y direction.
